Report Number: 11510

August 2011

Characteristics of the Vapour Cloud Explosion Incident at the IOC Terminal in Jaipur, 29th October 2009

GL Noble Denton

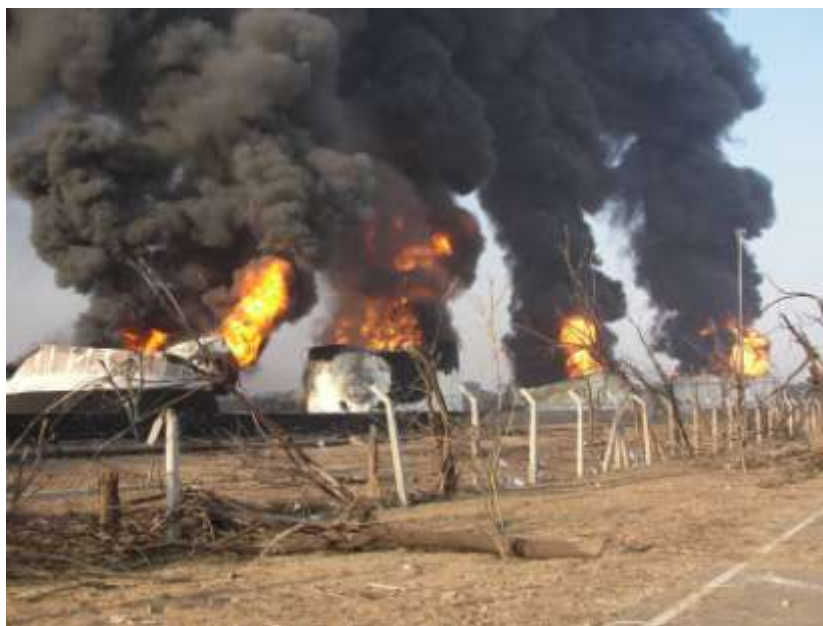
As already described, a vapour cloud explosion occurred following ignition. An assessment of the explosion damage is provided in Appendix A. However, the most obvious effect of explosion was damage to many of the tanks on the site resulting in extensive and long duration fires, as illustrated by Figure 3.

Figure 3: Tank Fires following the explosion (picture supplied by Sh. S.K. Hazra)

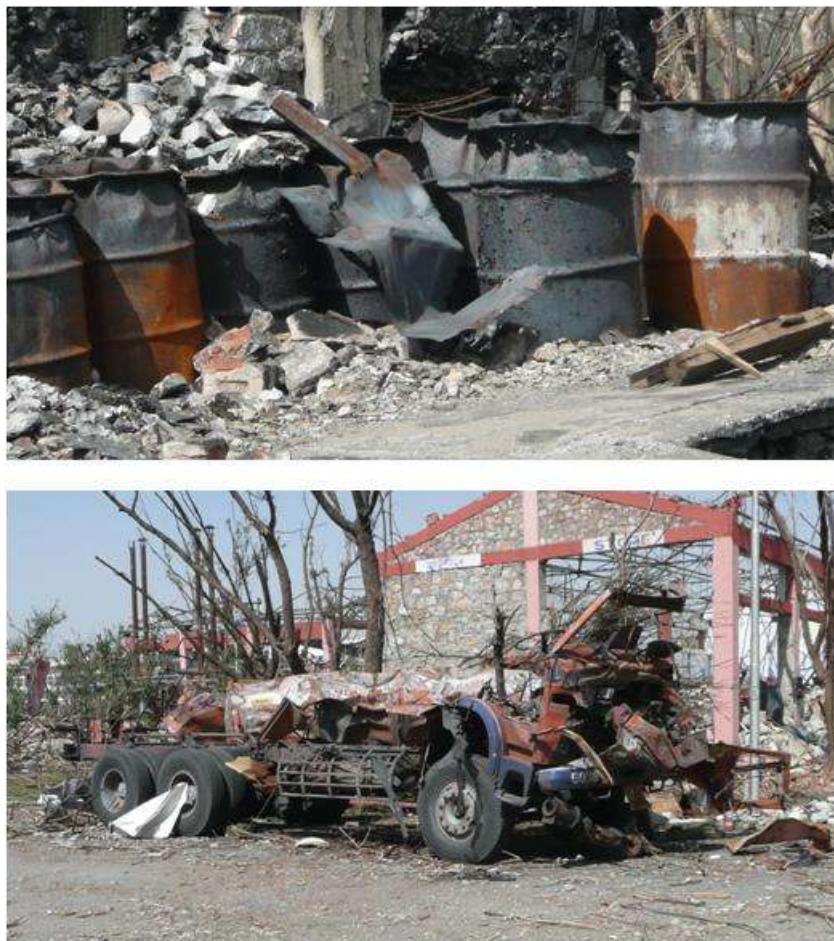
The incident on the IOC Jaipur terminal involved widespread severe pressure damage over almost the entire site. This evidence included overpressure damage to steel drums, steel boxes, vehicles, tanks and buildings. Examples of the damage observed are shown in Figure 4. This shows steel drums crushed down to their liquid level and a severely damaged road tanker.

Much of this evidence has a close similarity to the evidence observed in the Buncefield incident. As described in Appendix C, the evidence indicates that the vapour cloud explosion generated overpressures that were in excess of 200kPa over most of the IOC site. The evidence is not consistent with overpressure generation in one particular area producing a pressure wave that decays as it propagates away from the source and across the site.

Figure 4: Examples of Overpressure Damage

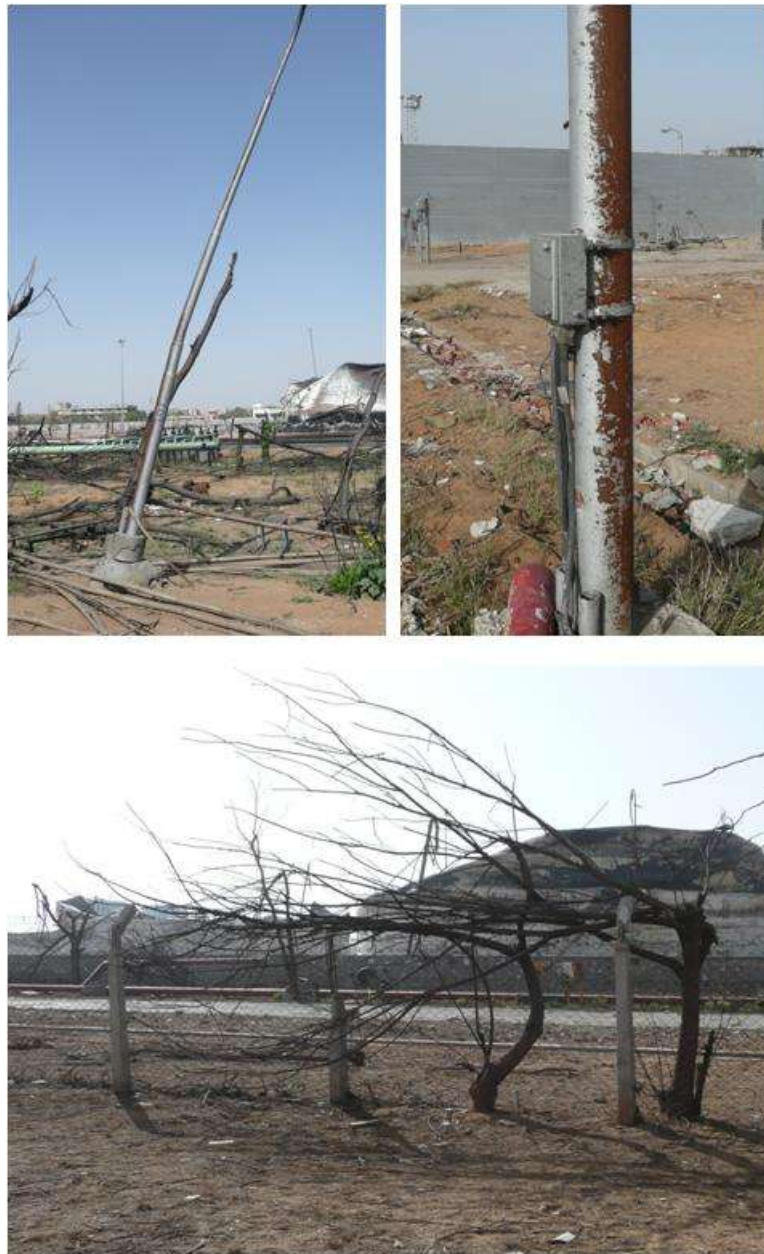
The directional indicator evidence was again very consistent with that observed at Buncefield. Examples of directional indicators are shown in Figure 5.

Figure 5: Example of directional indicators

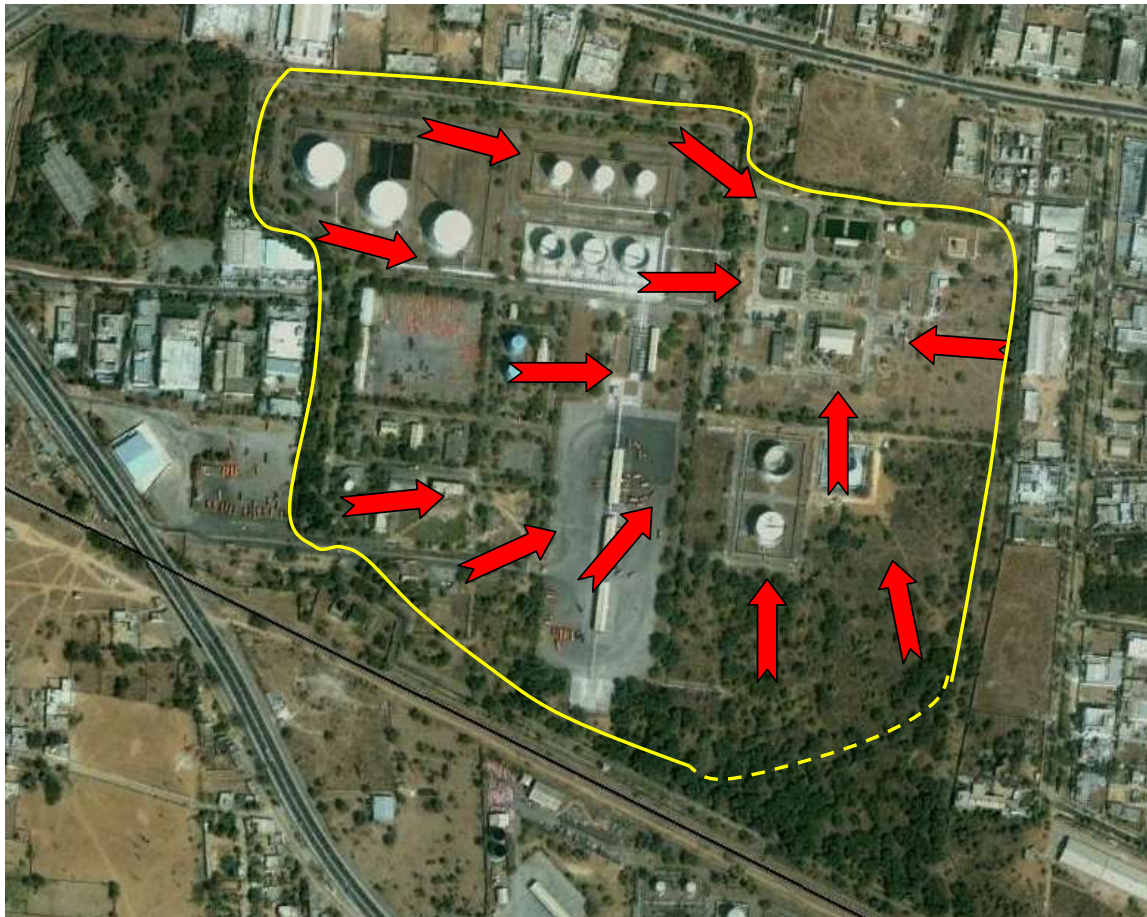
Figure 6: Overview of directional indicators and estimated cloud boundary (yellow line)

If it is assumed that a detonation was initiated in the incident, then the key issue is to try and identify where this initiation occurred. It is evident that all of the directional indicators point towards the Pipeline Division area, indicating that it was in this area that any detonation initiated. In fact, even if some as yet unknown explosion mechanism was proposed to explain the high pressure damage across the site, it would still require a source within this area⁶.

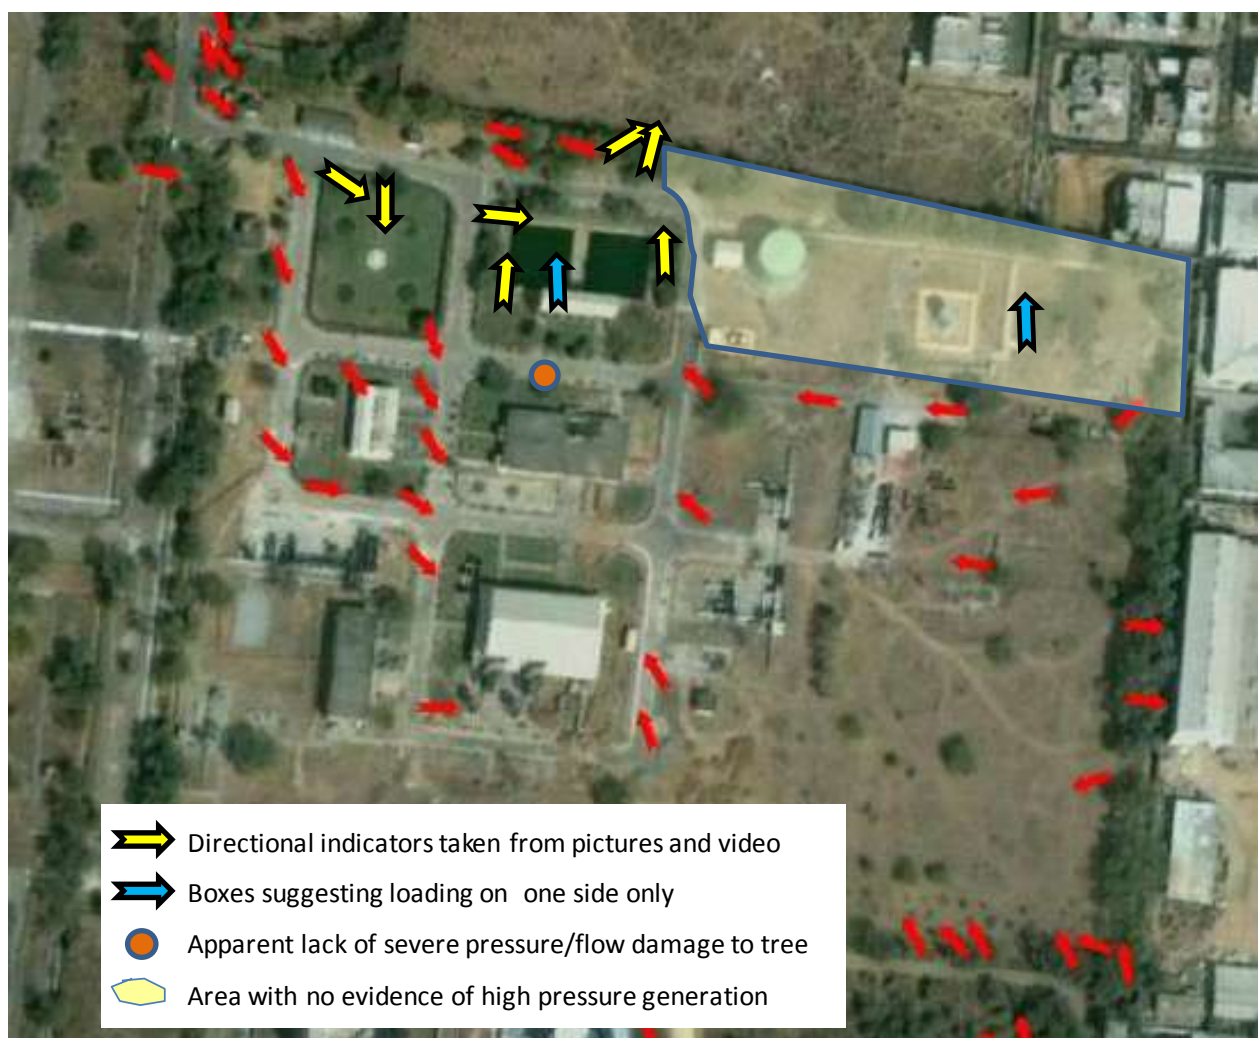
Approximate directional indicators interpreted from pictures and video taken in November 2009 are shown as yellow arrows. Similarly, approximate directional indicators corresponding to two boxes that appear to have been exposed to a directional pressure loading are shown as blue arrows (see Figure 65 and Figure 70 in Appendix A). Also shown are the positions of the tree to the north of the control room that does not appear to have suffered severe pressure/flow damage (see Figure 74 in Appendix A).

Figure 7: Directional indicators in the Pipeline Division area and area without apparent pressure generation

- The lack of damage to the wall. It remained standing in this area but collapsed further to the west on the north wall and to the south on the east wall.
- The limited damage to the trees to the east of the main firewater pump house.

- The lack of scouring on the lamppost by the green firewater tank.
- The lack of significant pressure damage in the area of the green firewater tank.
- The blue arrow marked in the shaded area is consistent with a pressure wave travelling into the area from an explosion event to the south of the shaded area.

It seems likely that a flammable cloud was present in the shaded area at the time of the explosion as the trees along the section of the north wall to the east of the green firewater tank were all fire damaged. In addition, there was no particular change in the ground level to in the vicinity of the green firewater tank that would have prevented the vapour cloud from spreading into this area. However, the possibility that the fire damage occurred as a result of fire propagating along the tree line after the explosion cannot be ruled out. In this scenario, it could be postulated that the vapour cloud in this area was below the lower flammable limit hence explaining the lack of pressure damage.

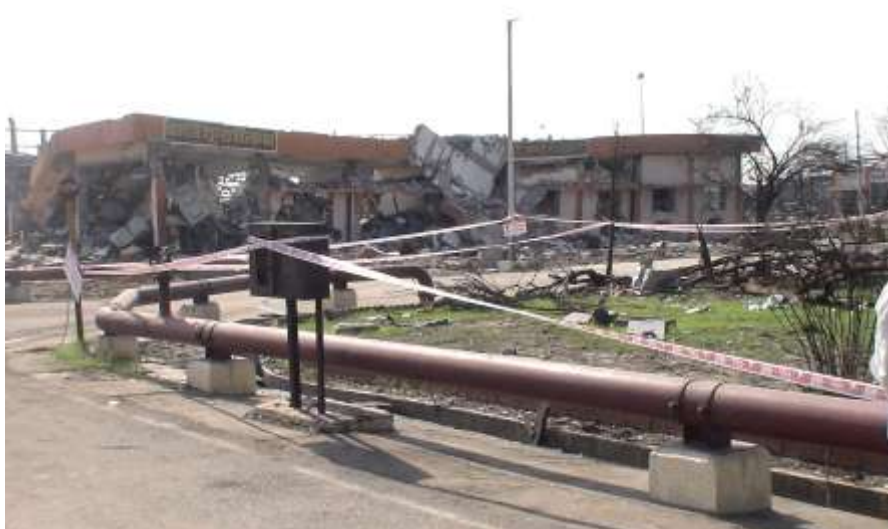
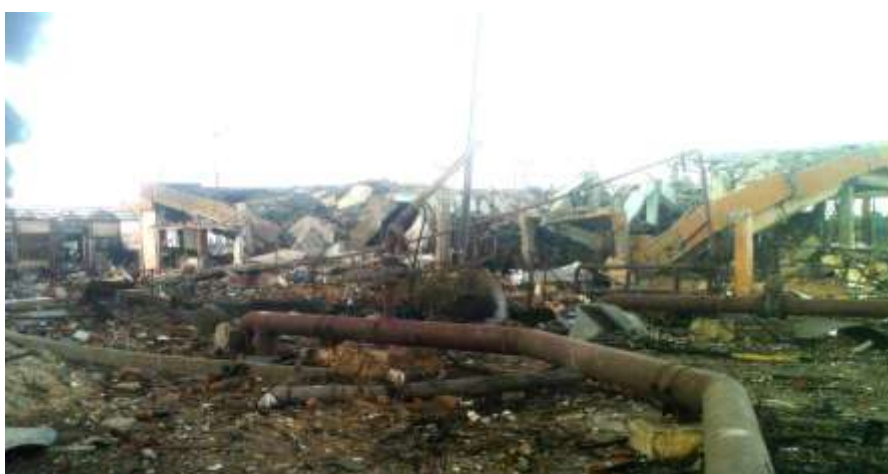
The damage to the control room is shown in Figure 8 viewed from the north and south. It can be seen that on the north side, the damage at the west end does not seem that severe, whereas the level of damage appears to increase towards the east end of the building. On the south side of the building however, the level of damage is much greater, with complete collapse of the building having occurred. The building gives the appearance of having been 'squashed' down on the south side.

- It appears to provide a dividing line between high pressure damage to the south and a lower level of damage on the north side. This is also supported by the apparent lack of damage to the tree on the north side of the control room that can be seen on Figure 8.

- The collapse of the roof downwards on the south side does not appear consistent with an internal explosion that vented out from the south side building. It might be expected that an internal explosion would have blown the roof upwards and away from the building. However, it is possible that the concrete roof would have had sufficient inertia such that it did not have a chance to move significantly during an internal explosion. If the flame venting from the building then resulted in a transition to detonation, the high external pressure could have pushed the partially failed roof downwards. In the absence of any further evidence, however, though this explanation could be considered to be physically plausible, it must be viewed as speculation.

Figure 8: Control room in Pipeline Division area (top picture from north taken by Dr B. Burgan, bottom picture taken from south by Sh. S.K. Hazra)

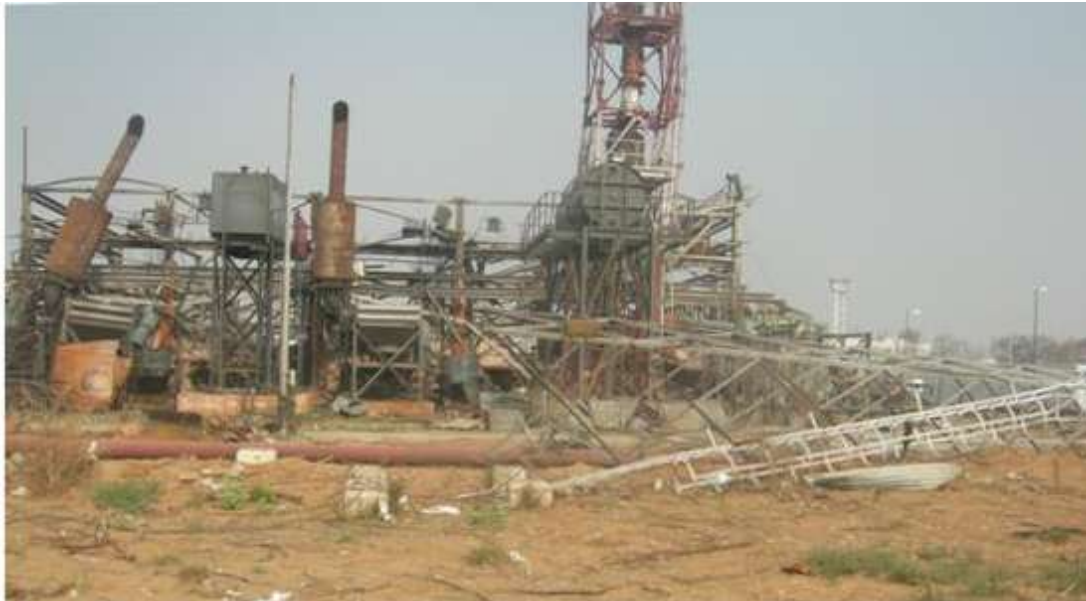
The damage to the pipeline pump house is shown in Figure 9. This picture was taken from the south of the building.

Figure 9: Pipeline pump house (picture taken by Sh. S.K. Hazra)

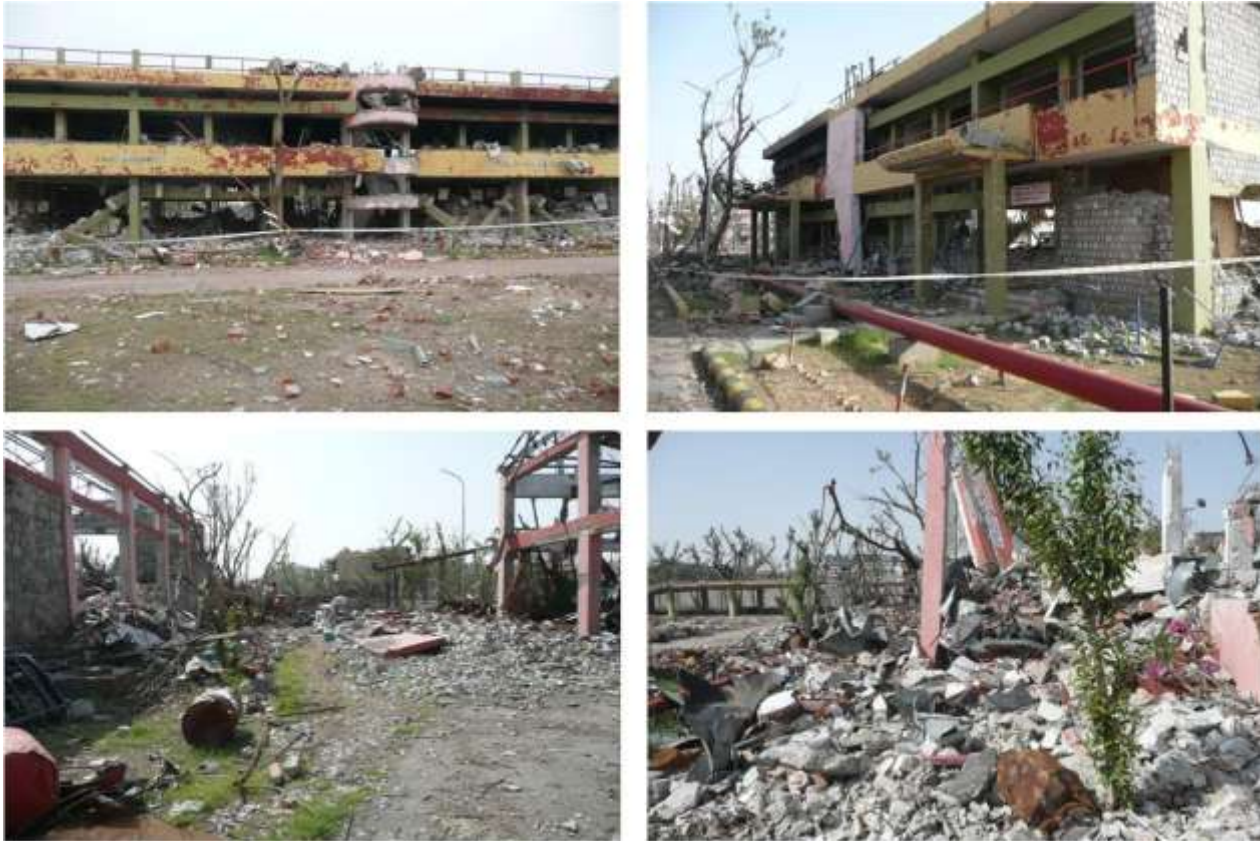
Figure 11: Damage to buildings including the Administration Building (top left) and the Business Continuity Building (top right)

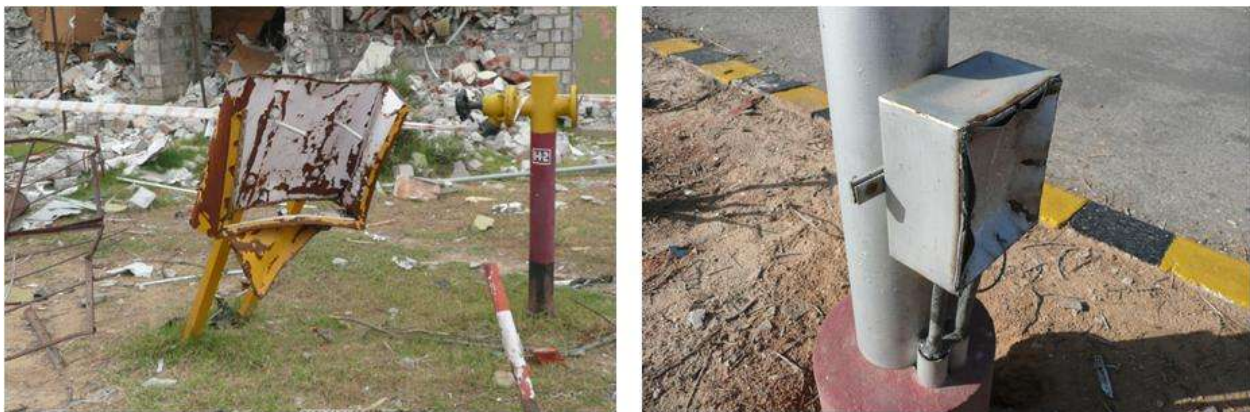
Damage to steel boxes was also evident, as illustrated in Figure 12. The larger box in this figure has been deformed rather than crushed. It is also notable that the whole box and supports are leaning over. This directional indicator was consistent with others in the area, pointing towards the east of the site.

Figure 12: Damage to boxes

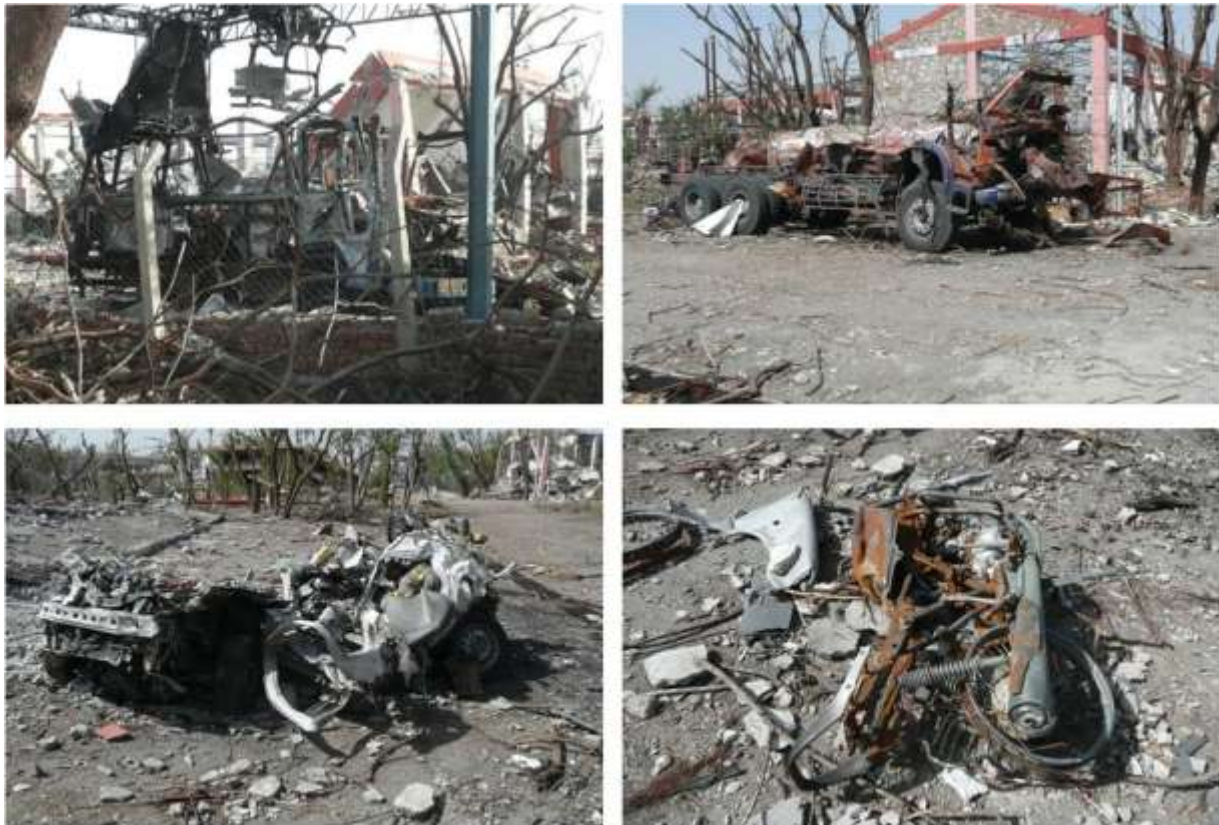
Damage to a number of motor vehicles was evident. As illustrated in Figure 13, damage was observed to a van (top left), a road tanker (top right), a car (bottom left) and a motor cycle (bottom right). It should be noted that the car had been in a car park where the concrete roof had collapsed, consistent with the flattening of the car. In all cases the level of damage was severe, with body panels being crushed or torn off. The tank⁷ on the road tanker had been crushed by the explosion, as had the tank on the motor cycle.

Figure 13: Examples of vehicle damage in south west area of the site

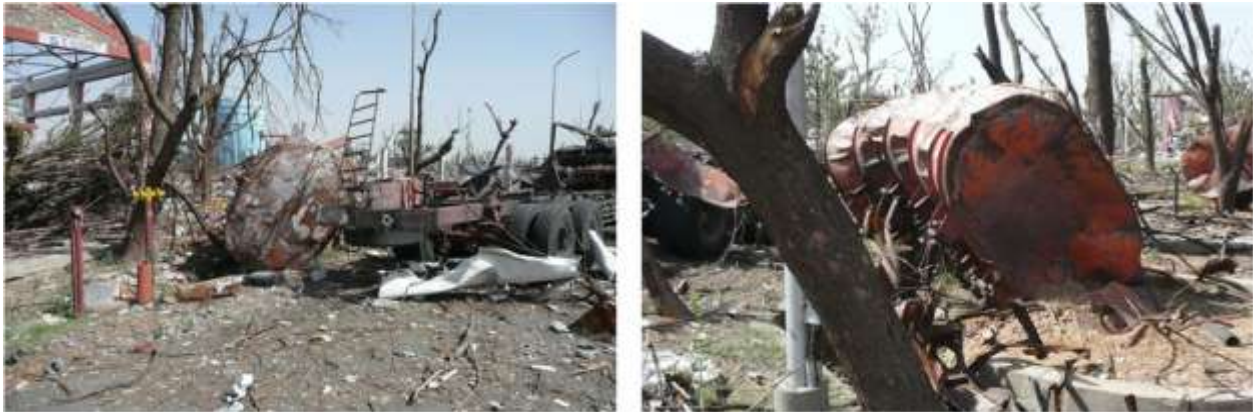
Figure 14: Road tanker with tank displaced and crushed

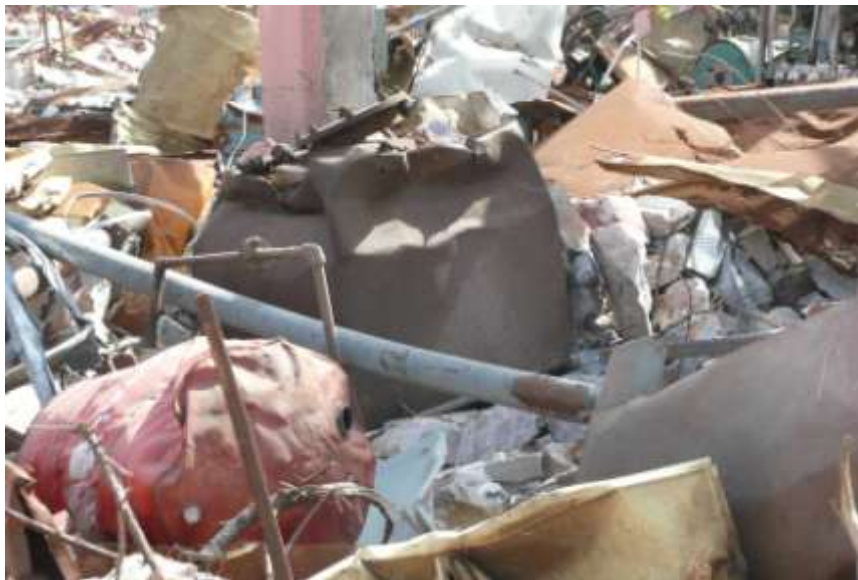
A tank in this area showed crushing above what is presumed to be the liquid level, Figure 15, which also shows a damaged steel drum.

Figure 15: Crushing of tank and steel drum

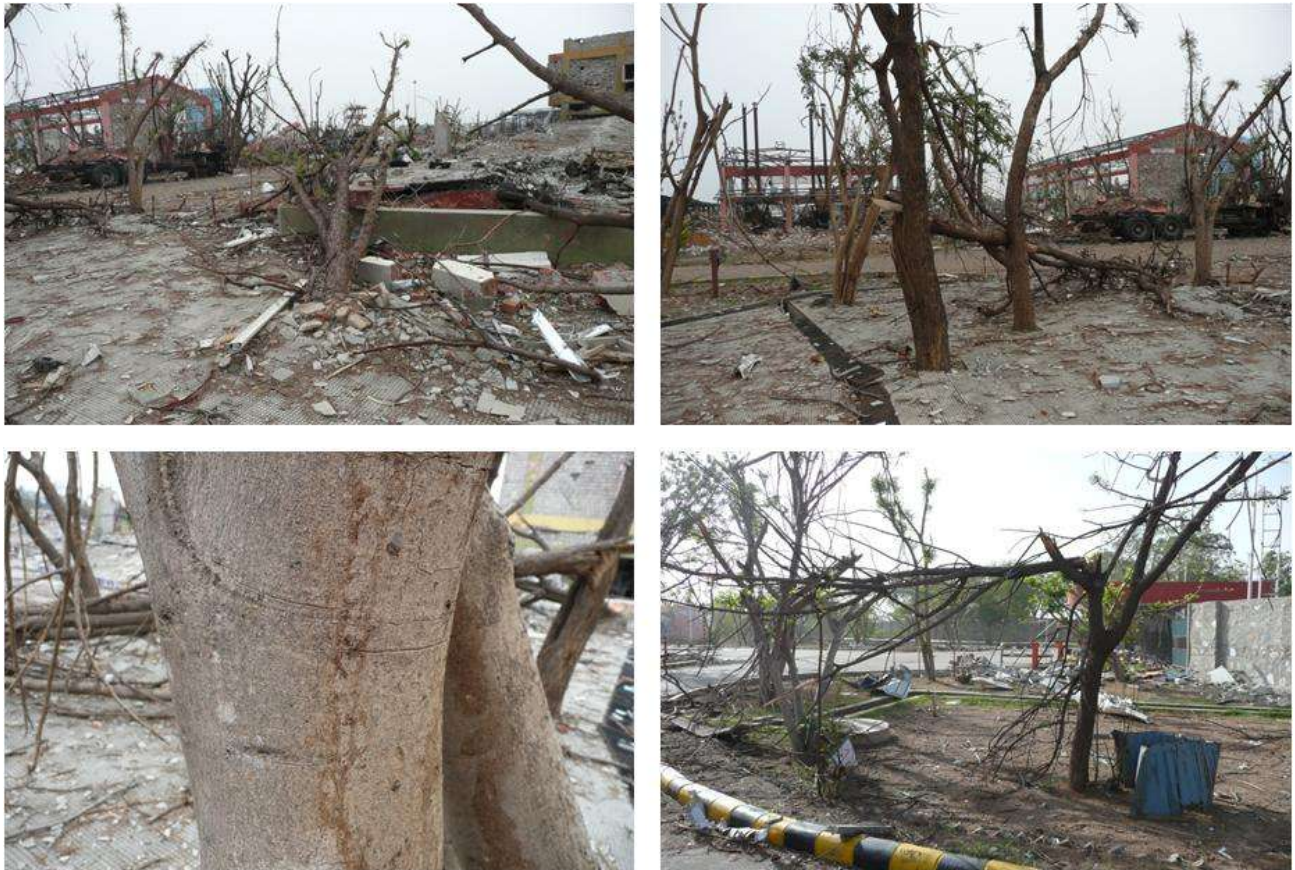
The lower right hand picture in Figure 16 shows a snapped branch pointing to the east of the site. The red roof of the gatehouse and the west wall of the site can be seen in the background of this picture, indicating that, close to the south west corner of the site, directional indicators were pointing to the east. (It should be noted that damage to the boundary wall around the full site had been repaired prior to the site visit in February.) Moving further east through the area, the directional indicators started to point more to the north east.

Figure 16: Directional indicators provided by trees

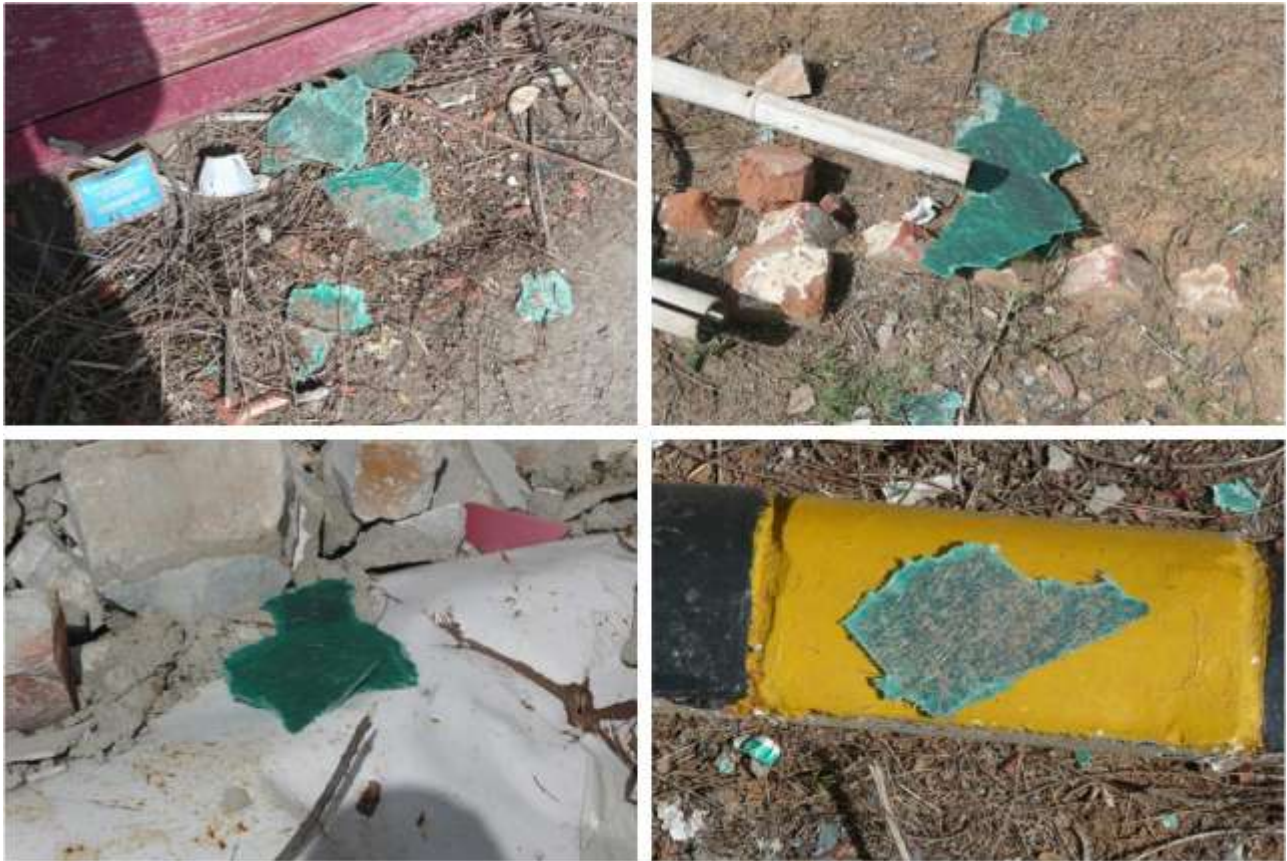
The fibreglass sheet had been broken up into many pieces and although some were irregular in shape, there was probably as many that were in near diamond or partial diamond shapes, as shown in Figure 18.

Figure 18: Broken pieces of the fibreglass sheet

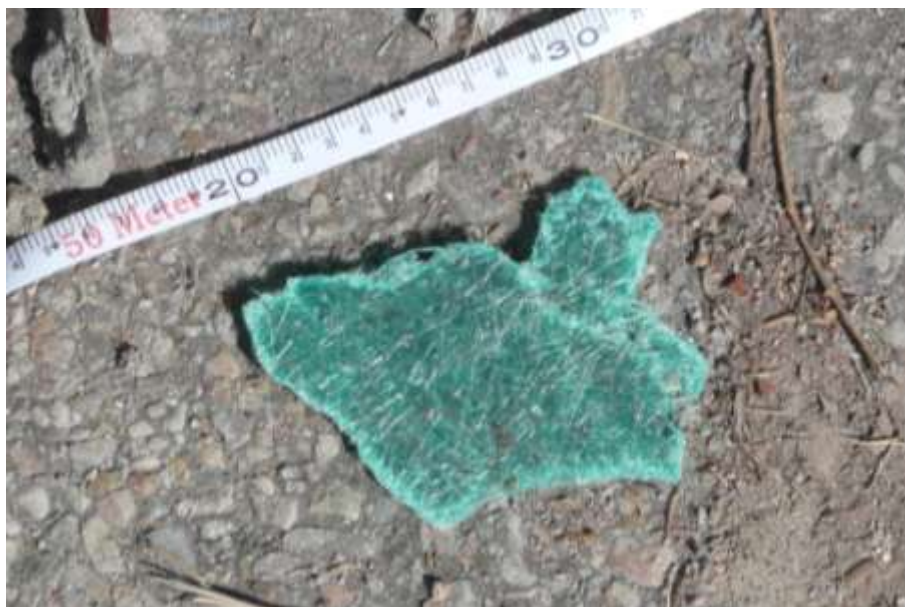
Figure 19: Single piece of diamond shaped fibreglass sheet (note fracture line along irregular edge)

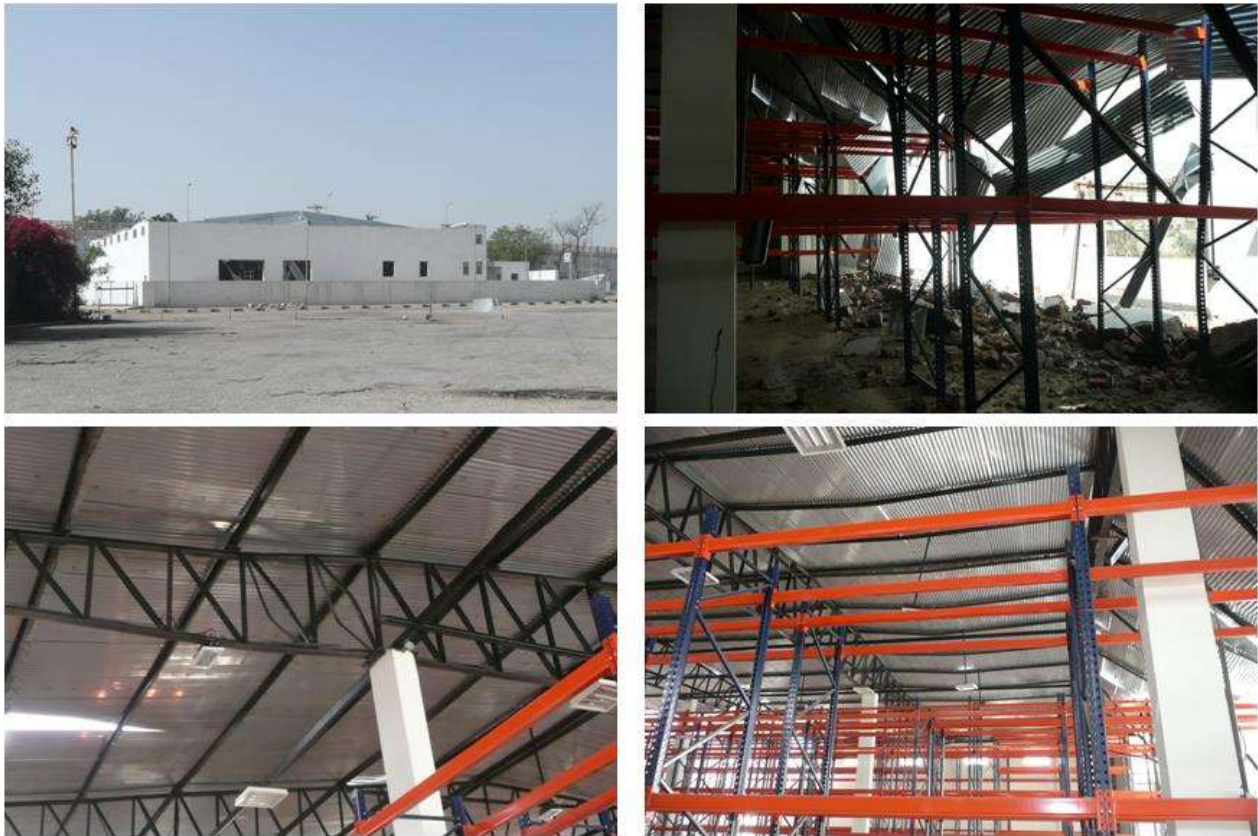
Though this building had been damaged, the scale of damage was much less than that observed to buildings just inside the site boundary. This would be consistent with rapid reduction in the overpressures from the edge of the flammable cloud (which, as discussed, the evidence suggests was close to the boundary wall). This rapid decay would also explain the apparent lower level of damage to the site gatehouse, which appears to have been very close to the edge of the cloud.

Figure 22: Damage to the Stores building

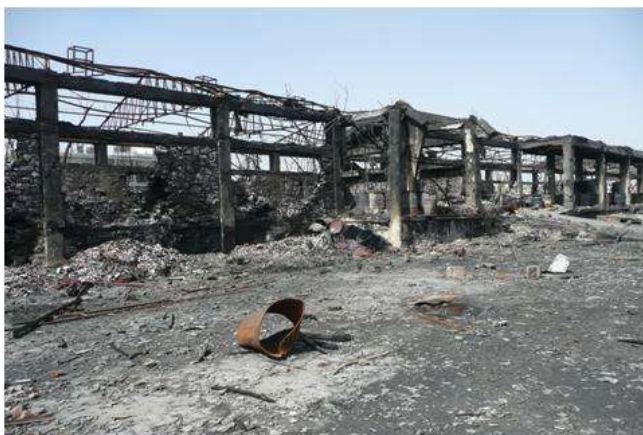
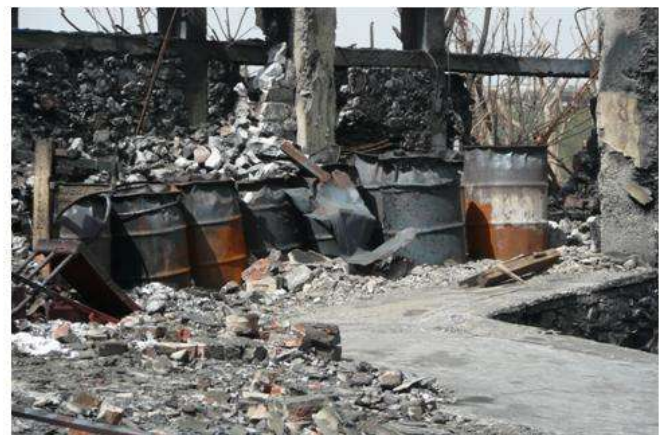
The warehouse had suffered both explosion and fire damage in the incident, as illustrated in Figure 24. Debris from the brick infill on the east side of the building had fallen outwards, possibly indicating an explosion within the building. A number of steel drums on the open loading bay showed clear evidence of crushing down to the liquid level, just as observed in the Buncefield explosion. These drums are shown in the right hand picture in Figure 24.

Figure 24: Fire and explosion damage to the warehouse and crushed drums on loading bay

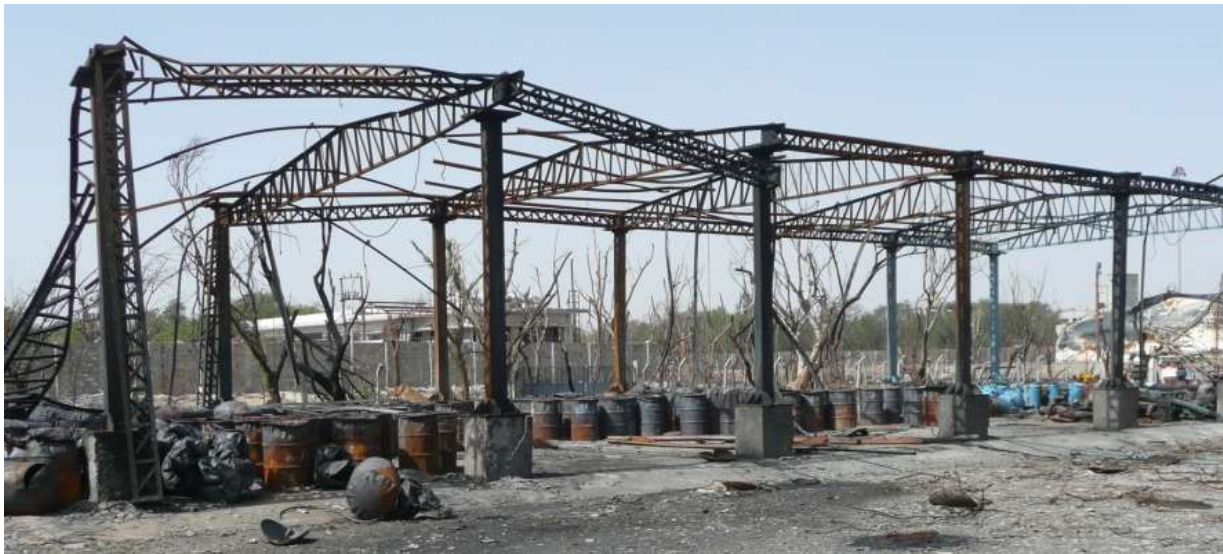
The covered area to the north of the warehouse was used for storage of steel drums, cylinders and other equipment. It can be seen in Figure 25 that in this area the steel drums also showed evidence of crushing at the top, extending down to the liquid level.

Figure 25: Covered storage area to the north of the warehouse

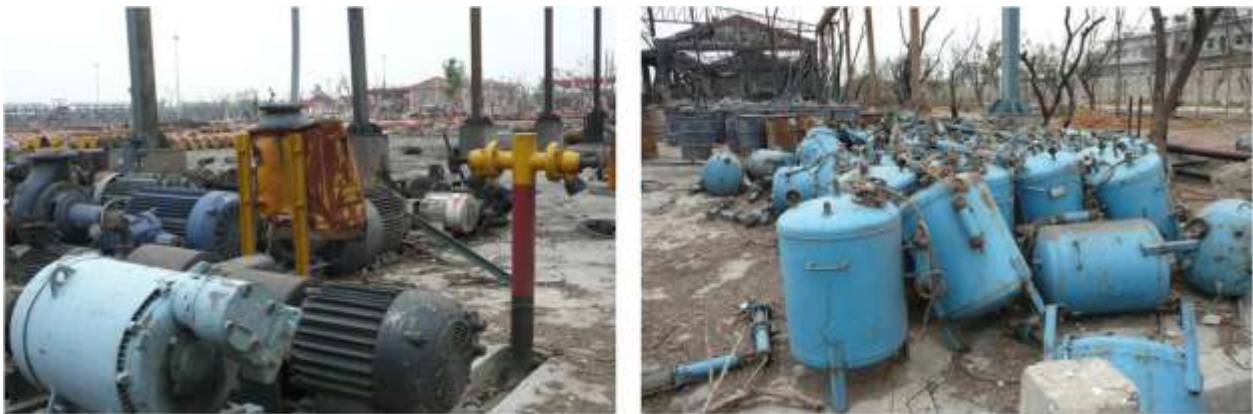
Other equipment stored in this area included electric motors, pumps and cylinders, which can be seen in Figure 26. This equipment showed no evidence of pressure damage, though a steel box in this area (centre of left hand picture) showed clear evidence of pressure damage.

Figure 26: Equipment in covered area

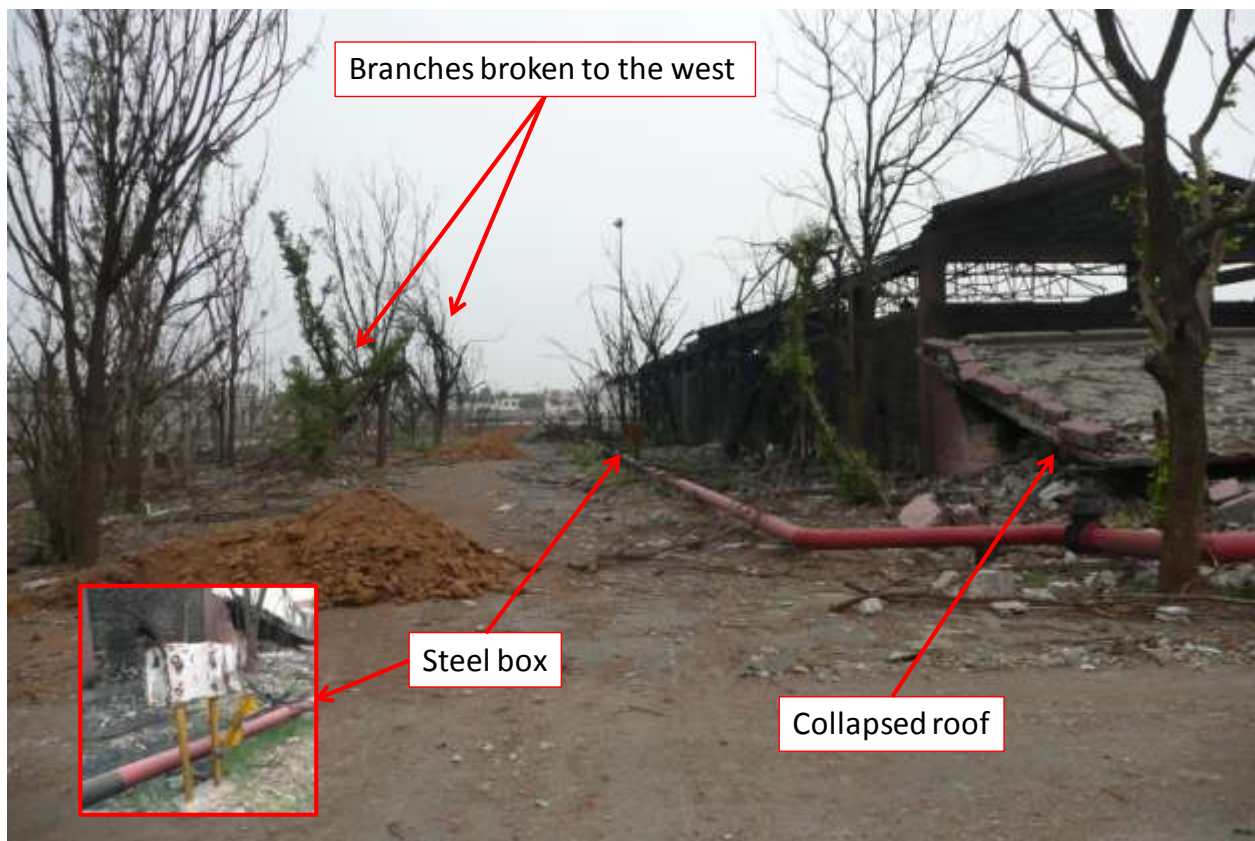
Figure 27 shows the rear (west side) of the warehouse viewed from the south end. It can be seen that a single storey building at the south end of the warehouse has collapsed and that some tree branches have broken in a westerly direction. A steel box directly behind the building showed pressure damage but was leaning slightly in an easterly direction (see inset picture taken from a different angle). This suggests that the edge of the flammable vapour cloud may not have extended to the site boundary behind (to the west of) the warehouse, but had only reached as far as the road that ran behind the warehouse.

Figure 27: View showing the rear side and south end of the warehouse

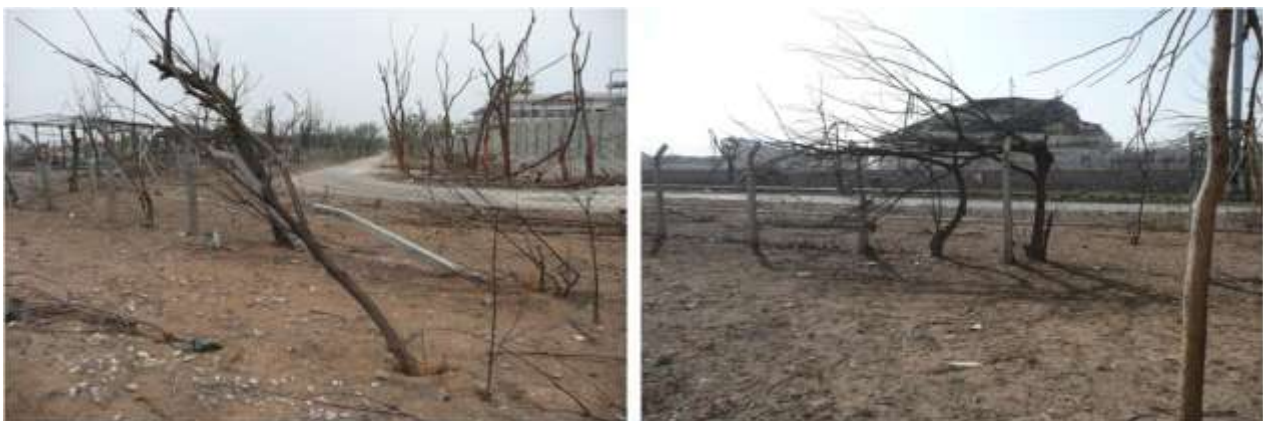
There were nine storage tanks in this area, 401 A/B/C, 402 A/B/C and 403 A/B/C. All of the tanks had been damaged by fire and as there was little other equipment in the bund areas, most of the evidence related to the explosion comes from the trees that round the north west corner and along the north side of the site. These trees generally provided very consistent directional evidence, with broken branches and uprooted trees pointing in an easterly direction, as shown in Figure 30. The amount of this evidence was considerable along the north side of the site. In addition these trees generally showed scouring consistent with gas flow in an easterly direction (note that some trees with particularly dark and corrugated bark did not appear as susceptible to the scouring or the scouring was not as evident).

Figure 30: Directional indication provided by trees in the main tank area

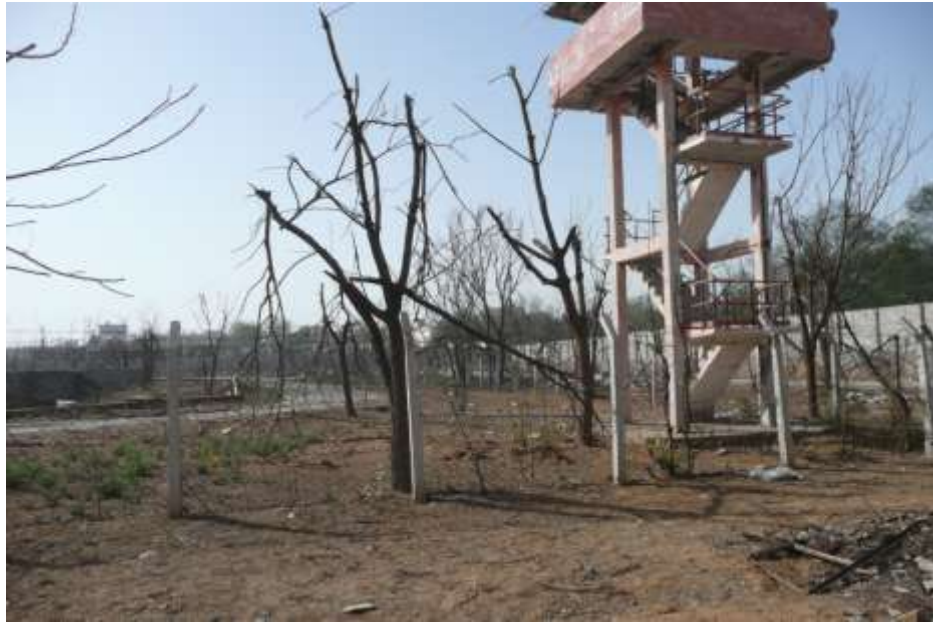
Figure 31: Branches broken to the west in the north west corner of the site (viewed south west)

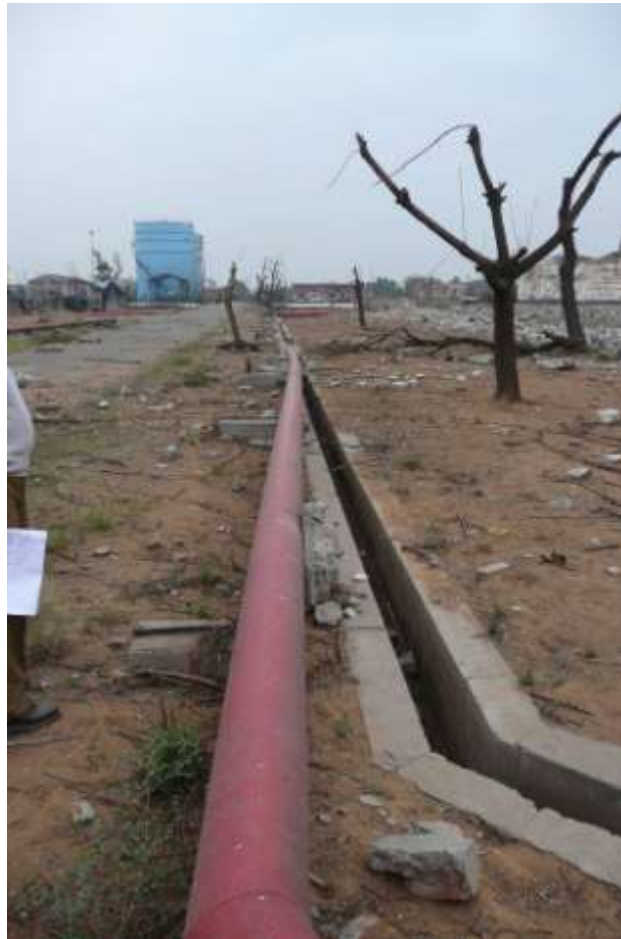
Figure 33: Displacement of firewater pipe to the west

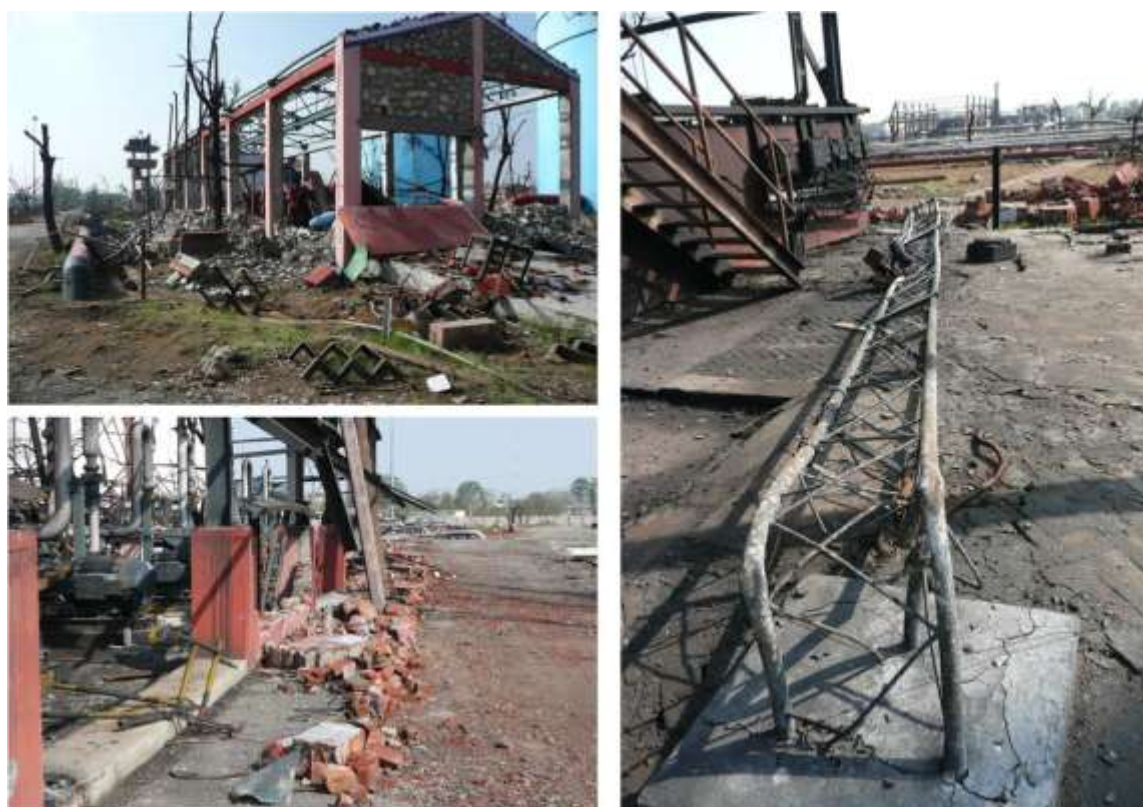
Figure 39: Damage to the firewater building (top left), the main product pump station (bottom left) and a collapsed CCTV tower at the south end of the main product pump station (right)

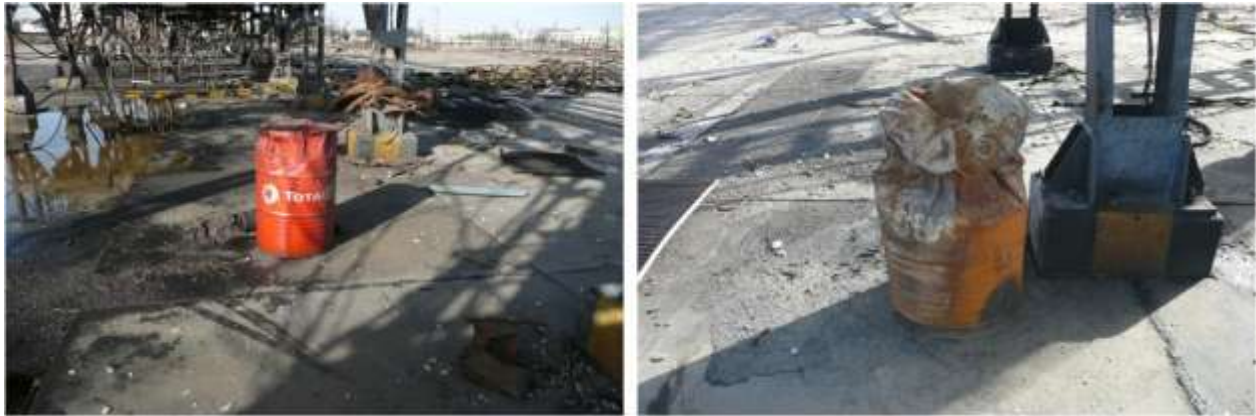
Figure 43: Steel drums under the loading gantry
