Report Number: 11510

August 2011

Characteristics of the Vapour Cloud Explosion Incident at the IOC Terminal in Jaipur, 29th October 2009

GL Noble Denton

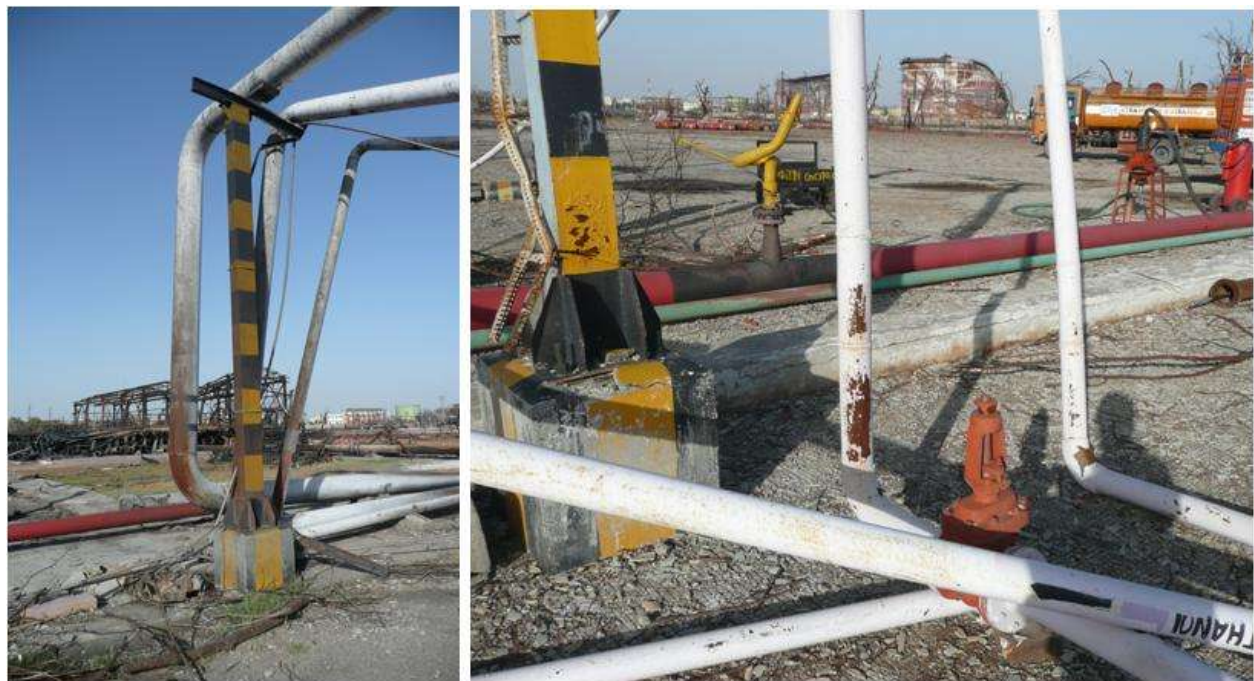
Directional indicators were present on this pipework and the supports in the form of scoured paintwork allowing the steel to rust.

Figure 46: Directional indicators on pipes and supports at the north (left) and south (right) of the tanker loading gantries

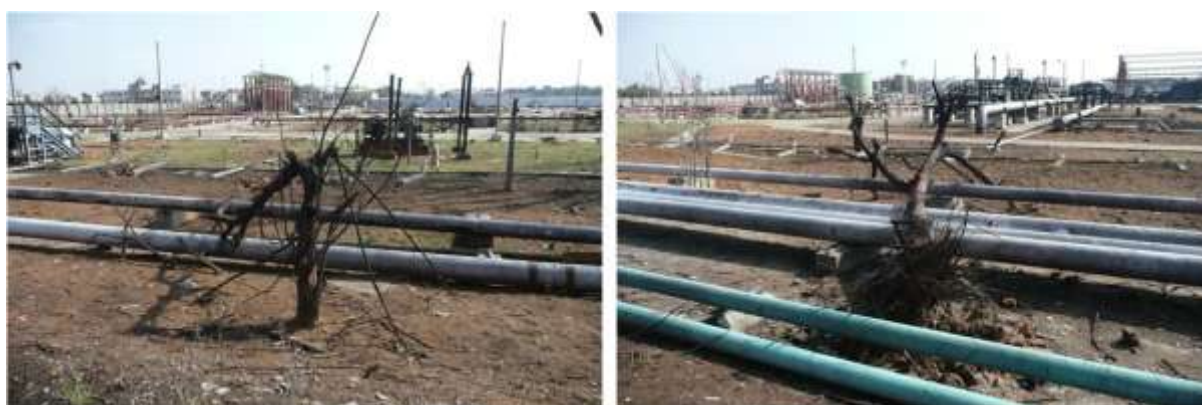
Figure 56: Broken and fallen trees to the west of the Pipeline Division area

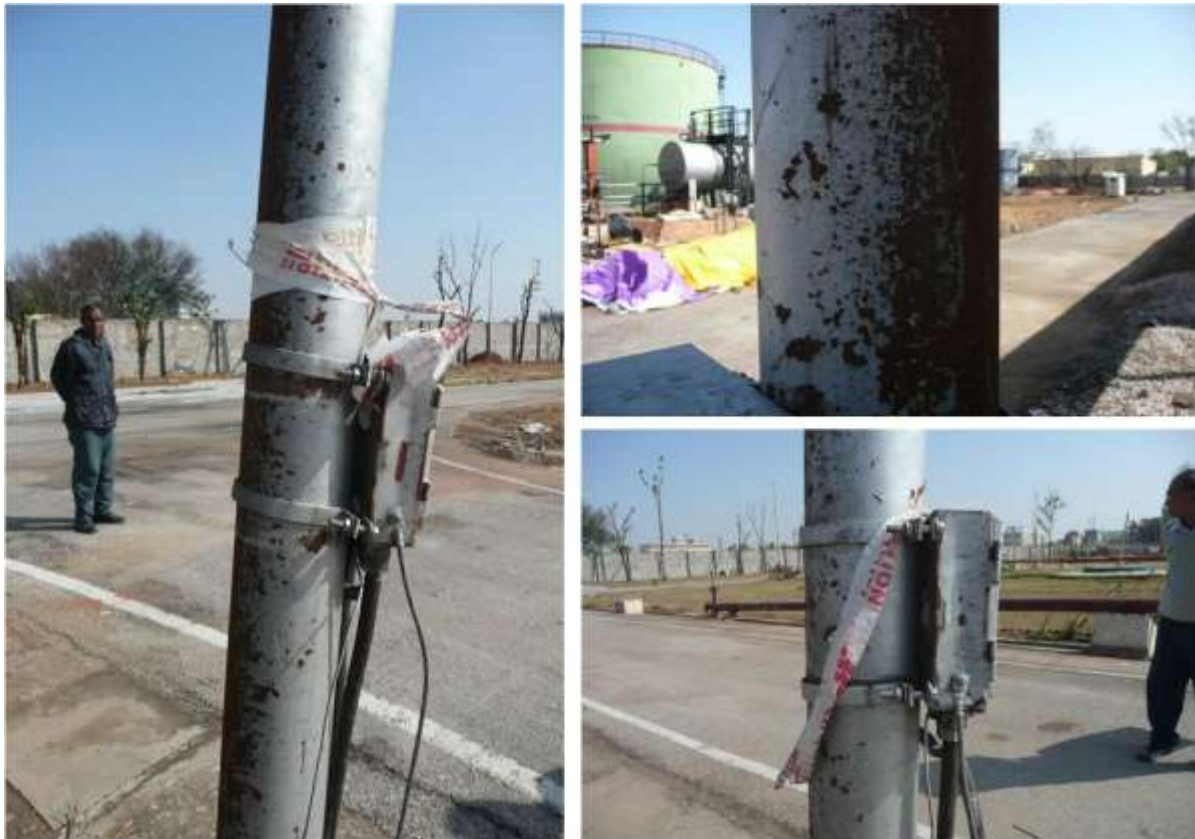
Figure 57: Scouring of paint on lampposts and crushing of boxes

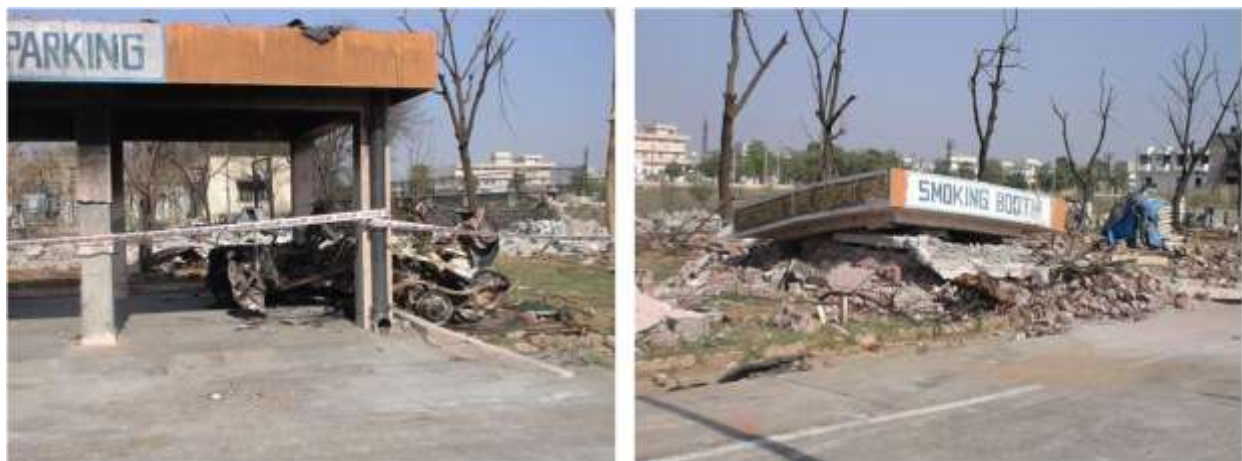
Figure 61: Damaged car in Pipeline Division car park and collapsed smoking booth (pictures taken by Dr B. Burgan)

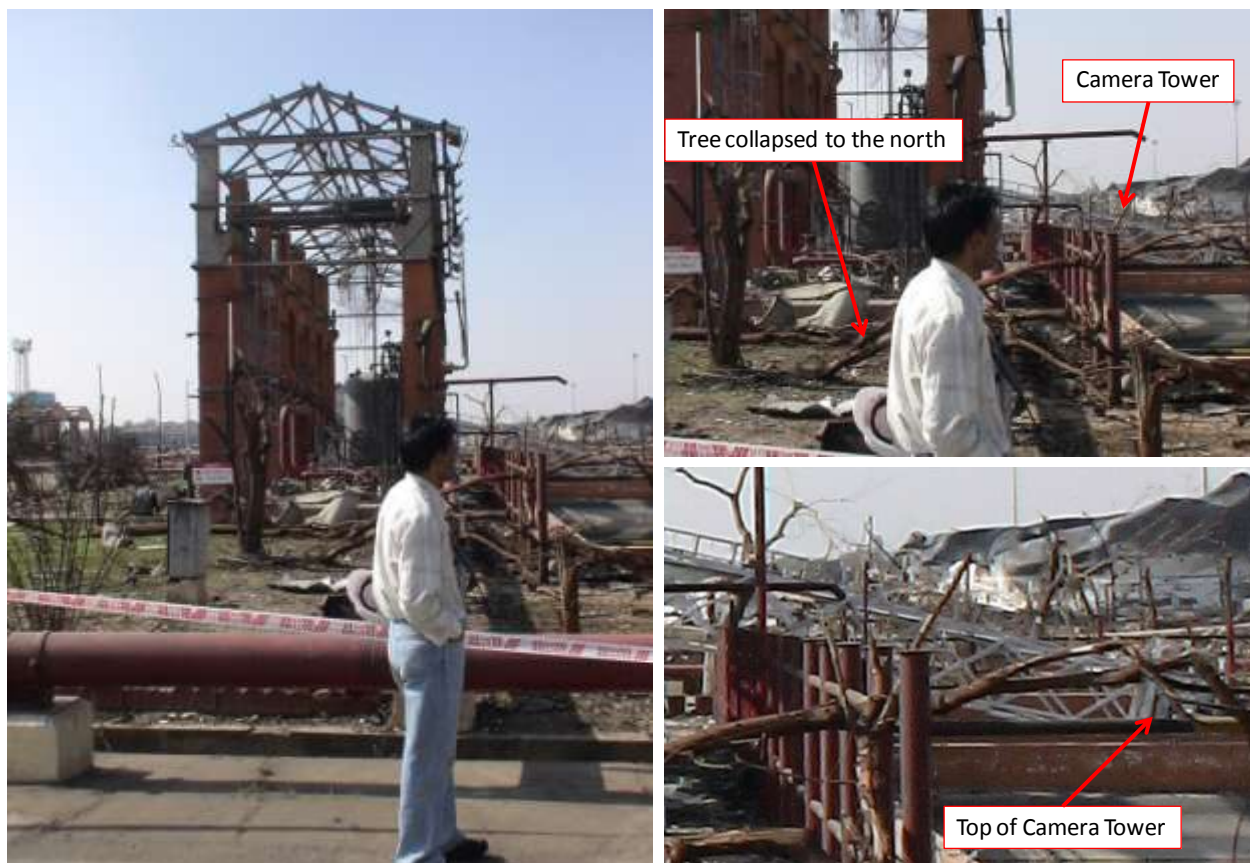
Figure 64: View from the east of the main firewater pump house looking west, showing collapsed trees and camera tower (picture taken by Dr B. Burgan)

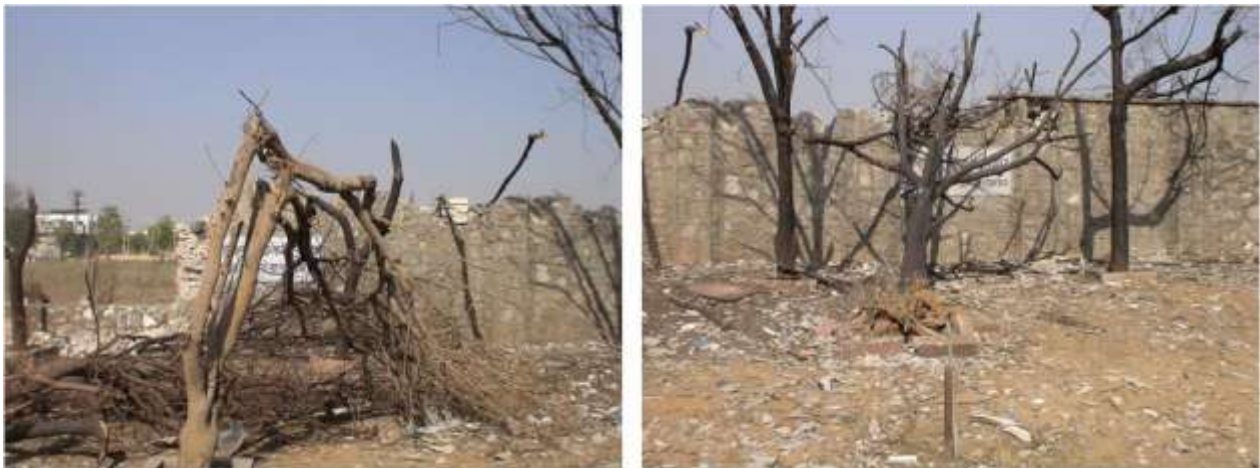
Figure 66: Trees broken/collapsed in a northerly direction (pictures taken by Dr B. Burgan)

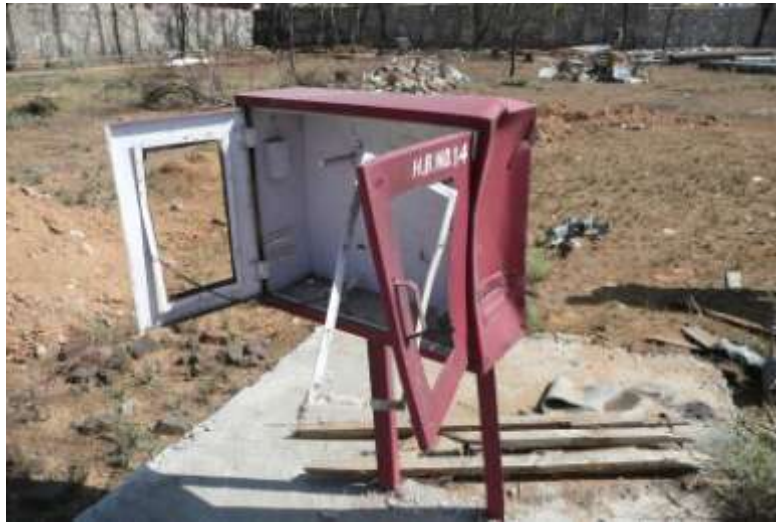
Figure 70: Red box showing uneven damage

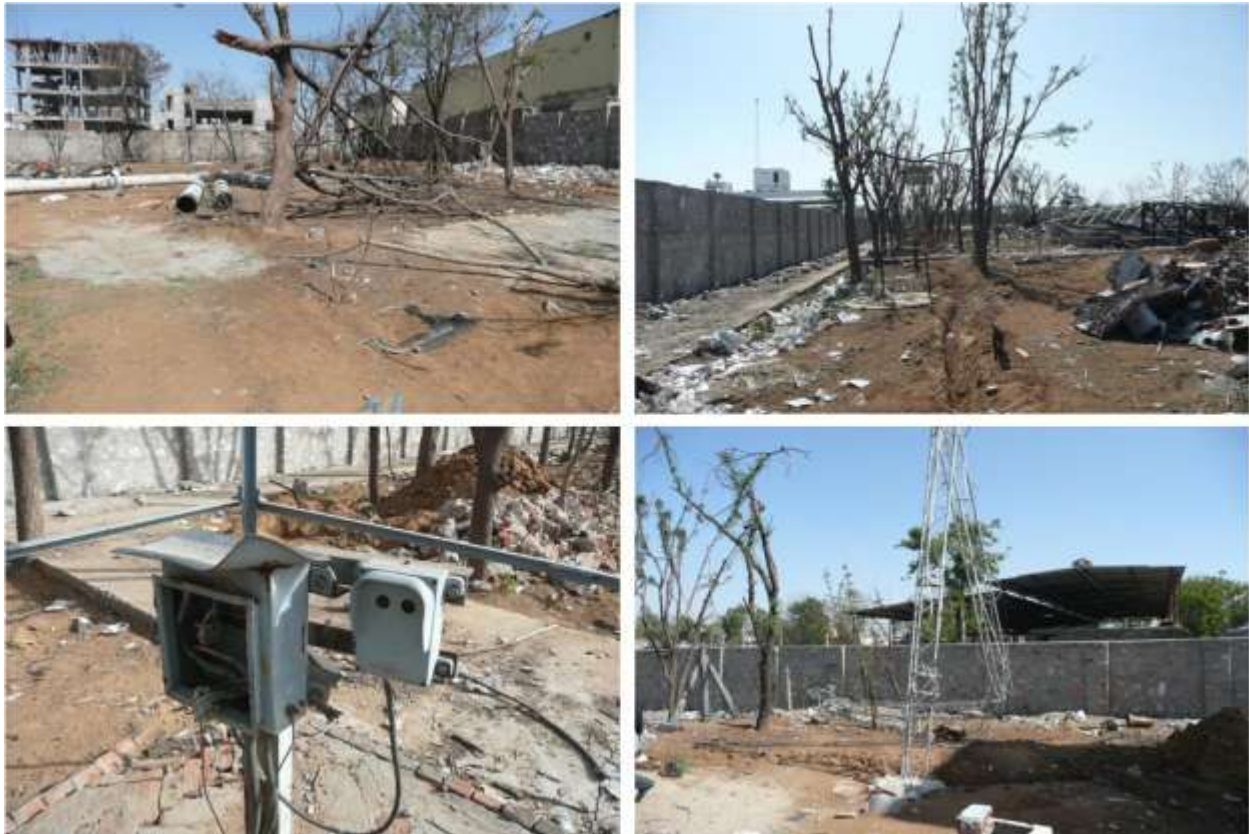
Figure 71: Damage and directional indicators along the east wall

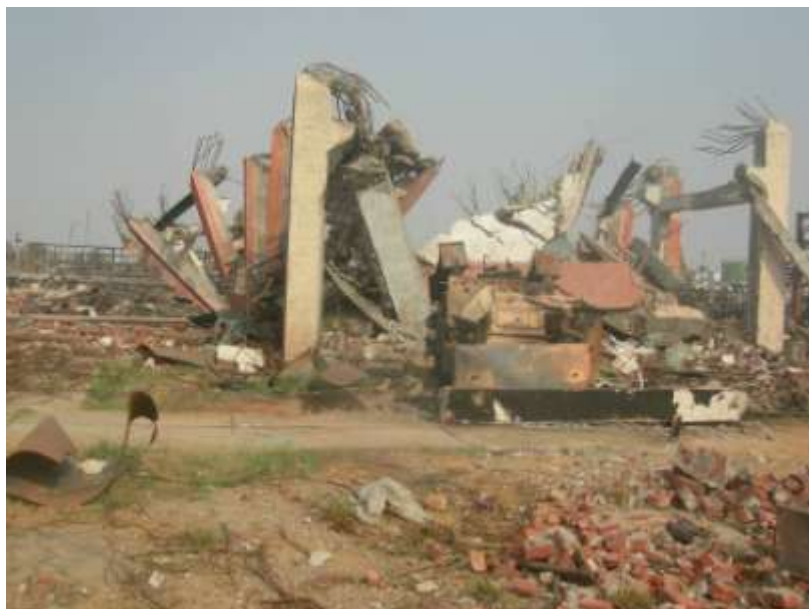
Figure 73 Damage to store building on Pipeline Division area picture (picture taken by Sh. S.K. Hazra)

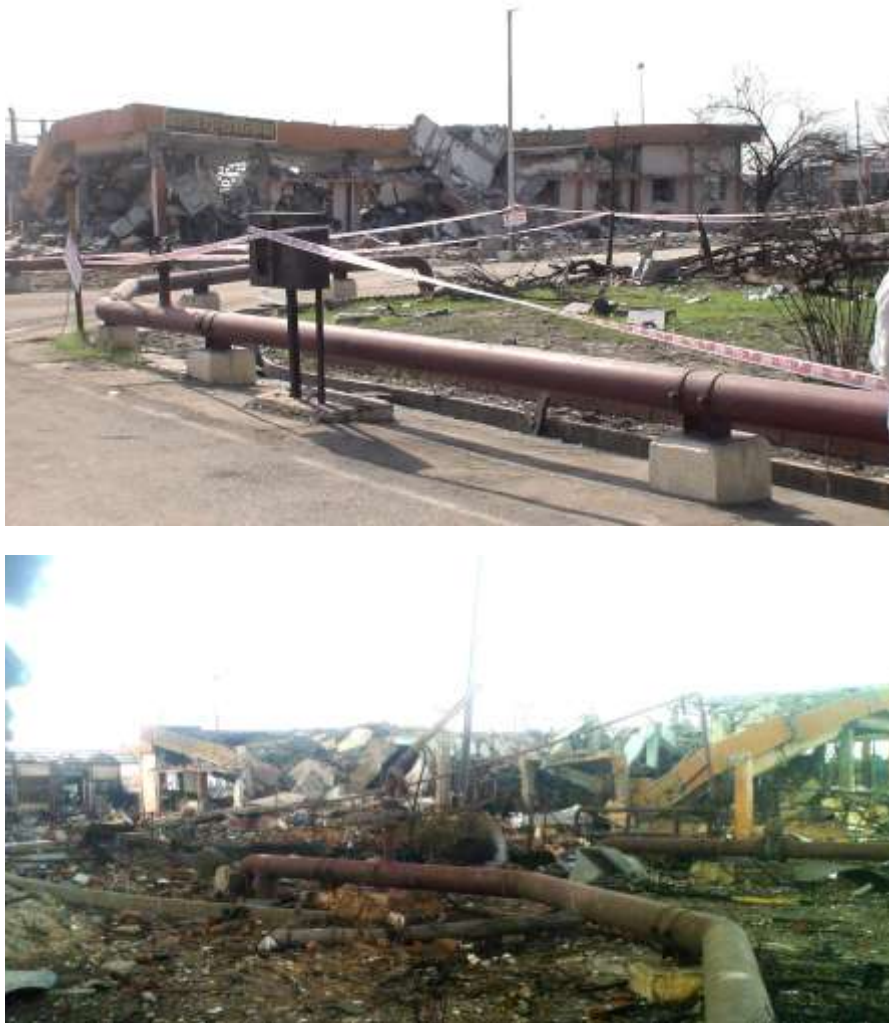
Figure 74: Damage to the Pipeline Division control building (top picture from north taken by Dr B. Burgan, bottom picture taken from south by Sh. S.K. Hazra)
