Report Number: 11510

August 2011

Characteristics of the Vapour Cloud Explosion Incident at the IOC Terminal in Jaipur, 29th October 2009

GL Noble Denton

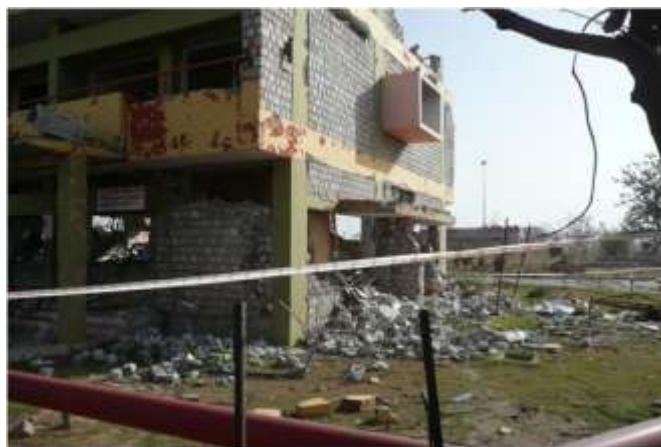
Figure 17: South end of the Business Continuity building

One additional item of evidence found within this area is worthy of mention, if not conclusive in itself. This relates to items of broken fibreglass sheet that were found in the debris at the south end of the Business Continuity building, which is the first building into the site from the gatehouse.

Personnel onsite confirmed that the fibreglass sheet had been mounted on a frame to provide a shade at the south end of the building, shown in Figure 17.

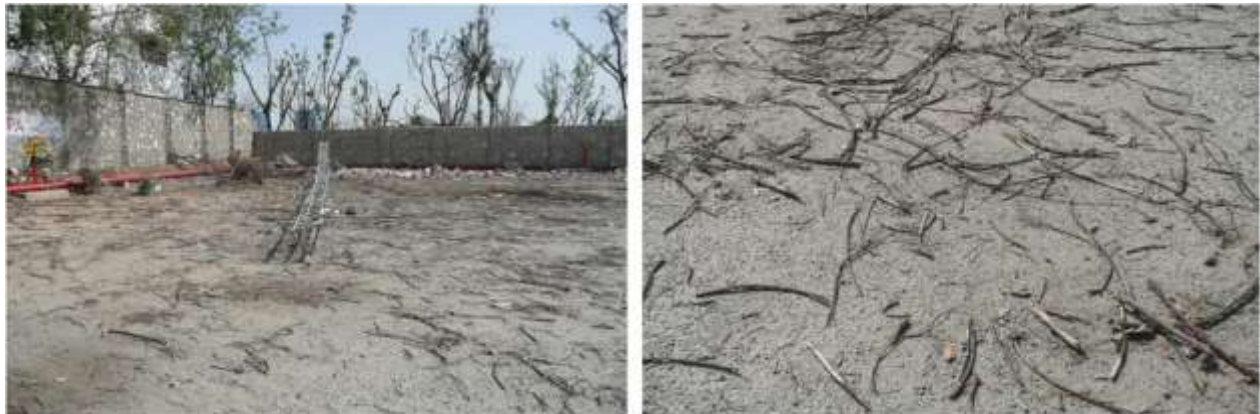
Figure 21: Collapsed CCTV tower and debris covering the car park

A CCTV camera tower in the north east corner of the car park and adjacent to the site wall had collapsed to the west as shown in Figure 16. This contrasted with directional indicators on the inside of the wall, which pointed to the east. Comparison with Buncefield suggests that the edge of the flammable (or detonable) cloud extended to a point close to the south end of the west boundary wall but not beyond it.

The figure also shows that the car park was covered with debris from trees, comprising mainly twigs. Site personnel confirmed that this was a result of the incident. Prior to the incident, the car park had been clear.

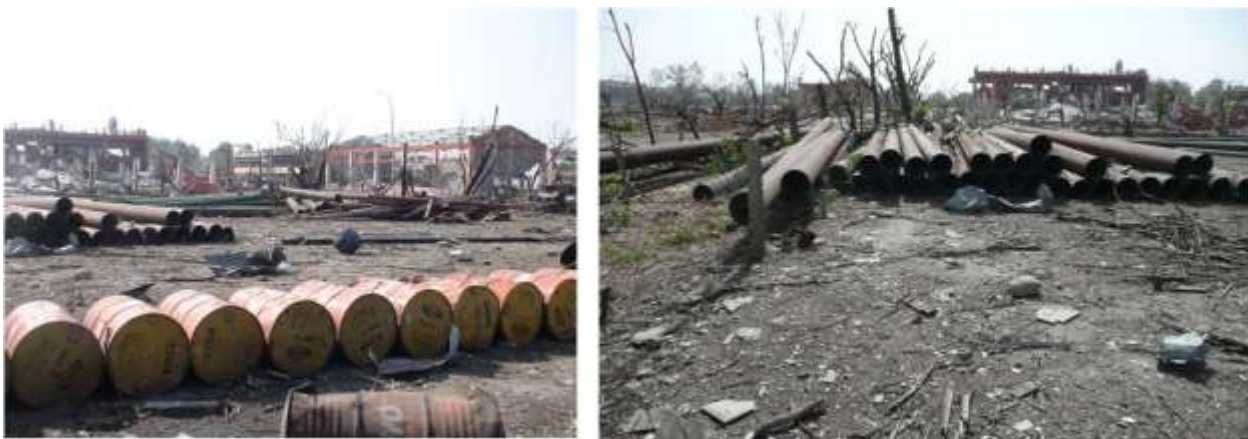
Figure 28: Lube barrel yard (left hand picture taken by Dr B. Burgan)

The lube barrel yard had contained steel drums containing lube oil, pipes and other general equipment, as shown in Figure 28.

The steel drums had mostly been on their sides and exhibited differing degrees of crushing damage. The pipes shown in the right hand picture of Figure 28 were located at the east end of the lube barrel yard and had been displaced to the east (left), with one pipe (out of picture) ending up on the other side of the road that ran along the east side of the lube barrel yard.

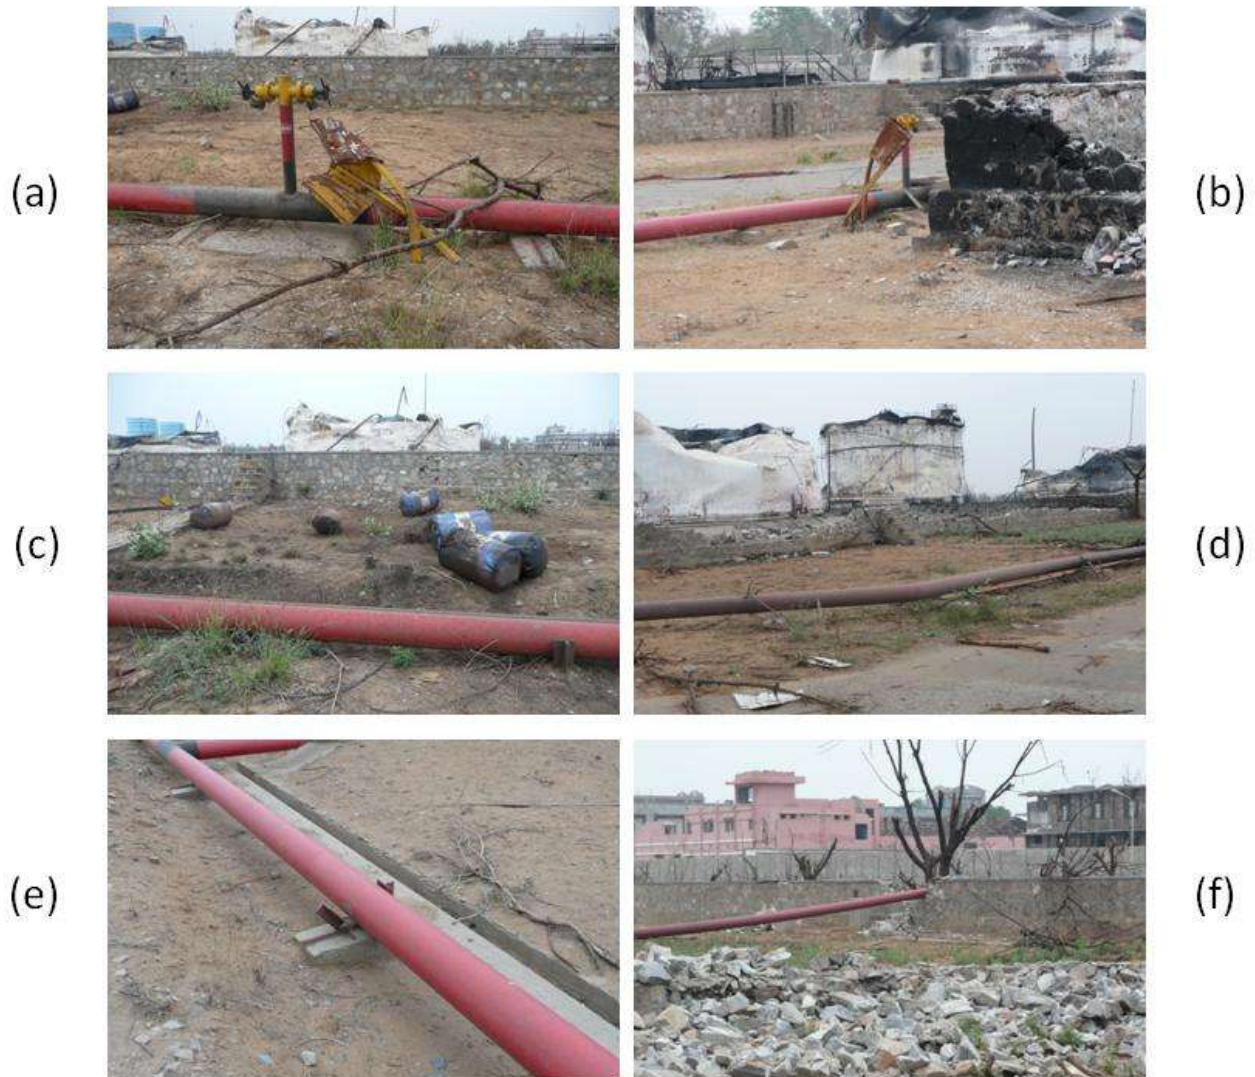
Figure 32: Other evidence in the main tank area

Other evidence observed in this area included damaged boxes, crushed drums, damaged walls and displaced pipes. This evidence is shown in Figure 32.

Figure 32 (a) and (b) show damaged steel boxes to the north of Tank 403B and at the north east corner of the bund around Tanks 403 A/B/C. These show consistent damage to other similar boxes on site and the one in Figure 32 (a) has also been displaced towards the east.

Figure 32 (c) shows steel drums that have been both crushed and heat affected. These were also to the north of Tank 403B, adjacent to the steel box in Figure 32 (a).

Figure 32 (d) shows the west wall of the bund around Tanks 402 A/B/C. This wall had collapsed towards the east, as had parts of other bund walls that ran north south.

Figure 32 (e) shows damaged pipe retainers on the east side of a firewater pipe running north south. Figure 32 (f) shows damage to the north wall of the bund for Tanks 403 A/B/C due to the easterly displacement of the firewater pipe leading to Tank 403C.

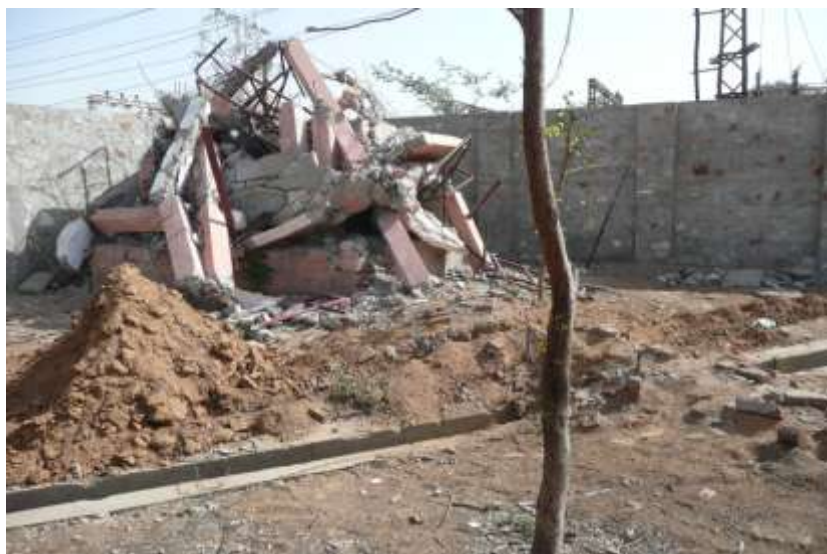
Figure 34: Collapsed guard tower on north wall

Finally for this area, the guard tower located about half way along the north wall (where the boundary kinks in slightly) suffered complete collapse, as shown in Figure 34. (Again it should be noted that the northern boundary wall had been rebuilt prior to the site visit in February.

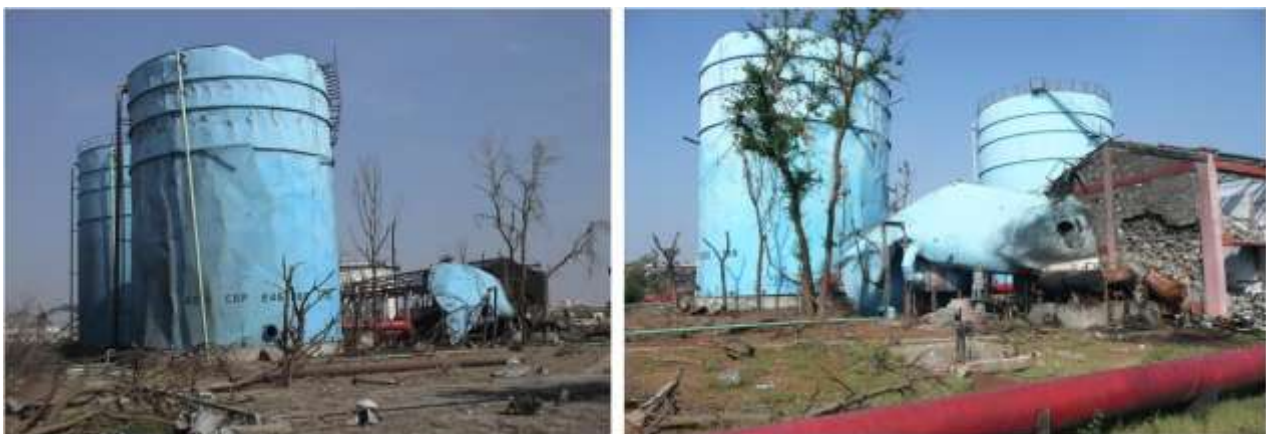
Figure 36: Firewater Tanks viewed from slightly west of south (left) and south east (right) (left picture taken by Dr B. Burgan)

The two blue firewater tanks were the most prominent feature of the site. At the time of the explosion, one of these tanks was near full and the other was empty and open to atmosphere to allow maintenance.

Figure 36 shows two views of the tanks. The tank in the foreground in the left hand picture and on the left in the right hand picture was the empty tank. The roof had blown off the empty tank, landing to the east of the tank. This is most likely due to flammable mixture being present inside the tank as it was open to the atmosphere at the time of the incident.

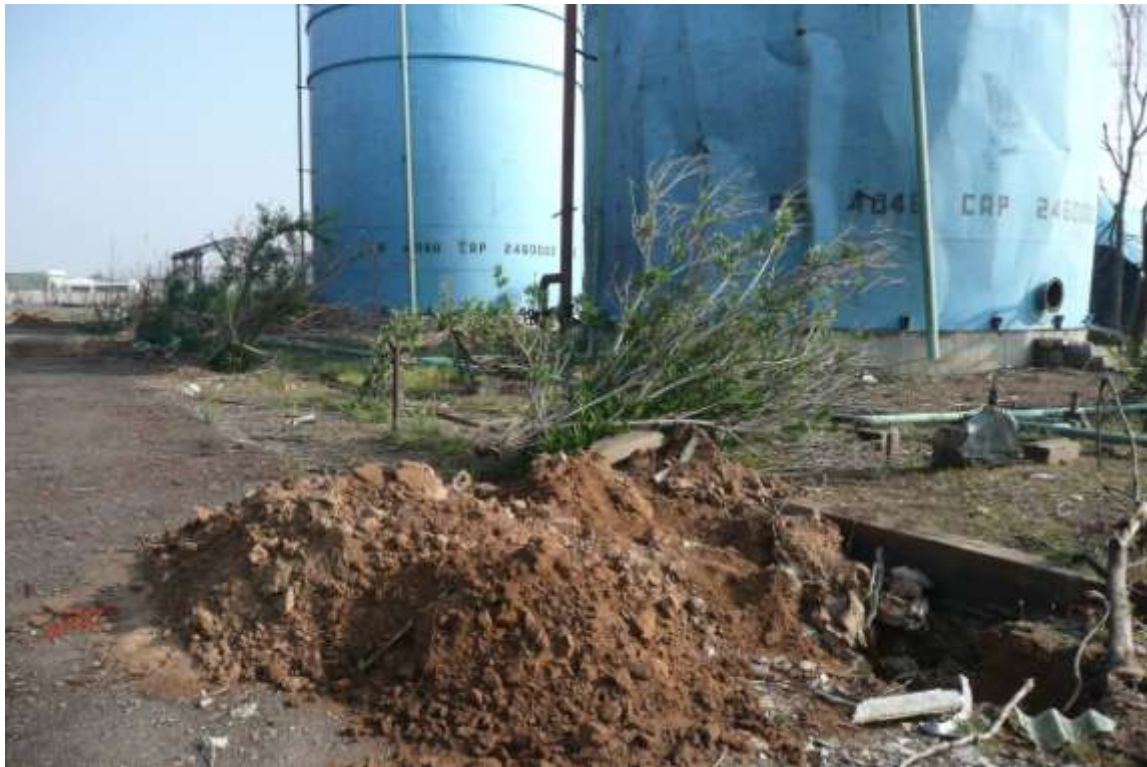
Figure 37: Firewater tanks viewed from south west

It can be seen from Figure 37 that the empty tank, in the foreground, also suffered crushing damage that did not occur on the full tank. This figure also shows directional indicators in the form of bushes that have fallen over pointing in an easterly direction.

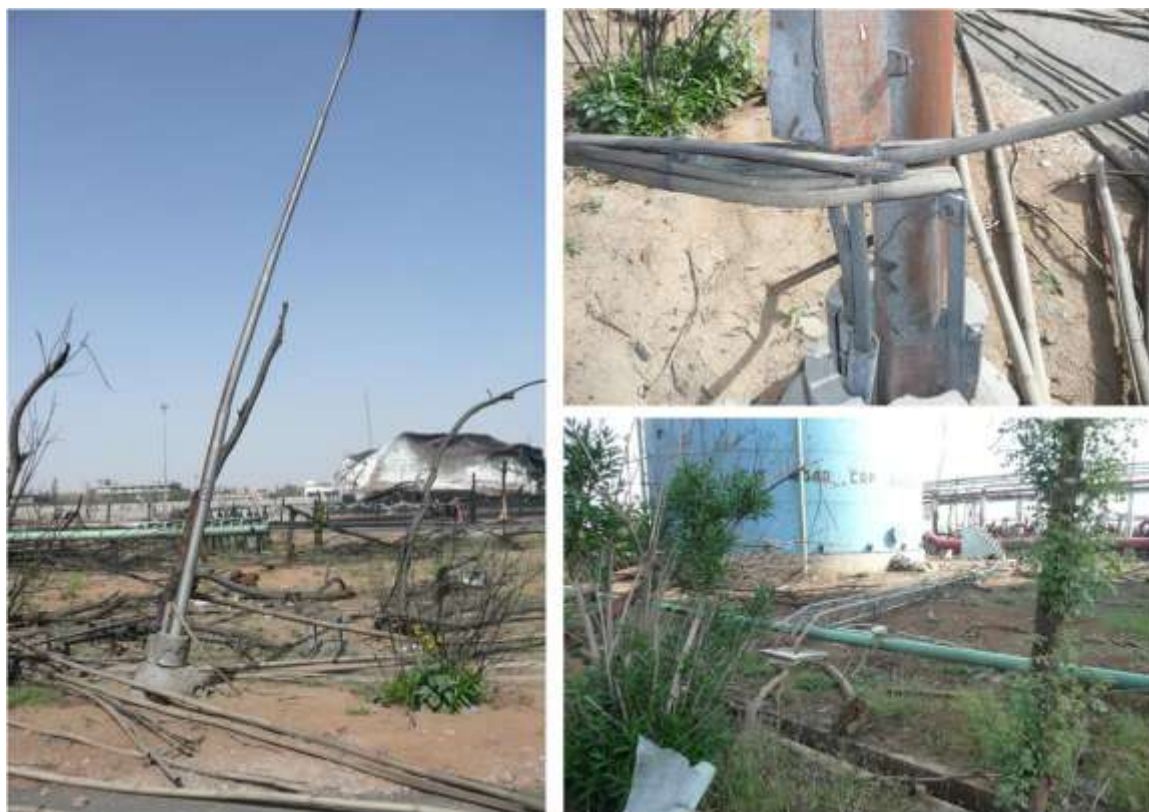
Figure 38: Directional indicators in vicinity of the firewater tanks

Other directional indicators were present in this area, as illustrated by the pictures in Figure 38. This shows a lamppost leaning to the east, scouring on a lamppost and box and a collapsed CCTV tower. In all cases (not just those shown in this figure) the indicators pointed in an easterly direction.

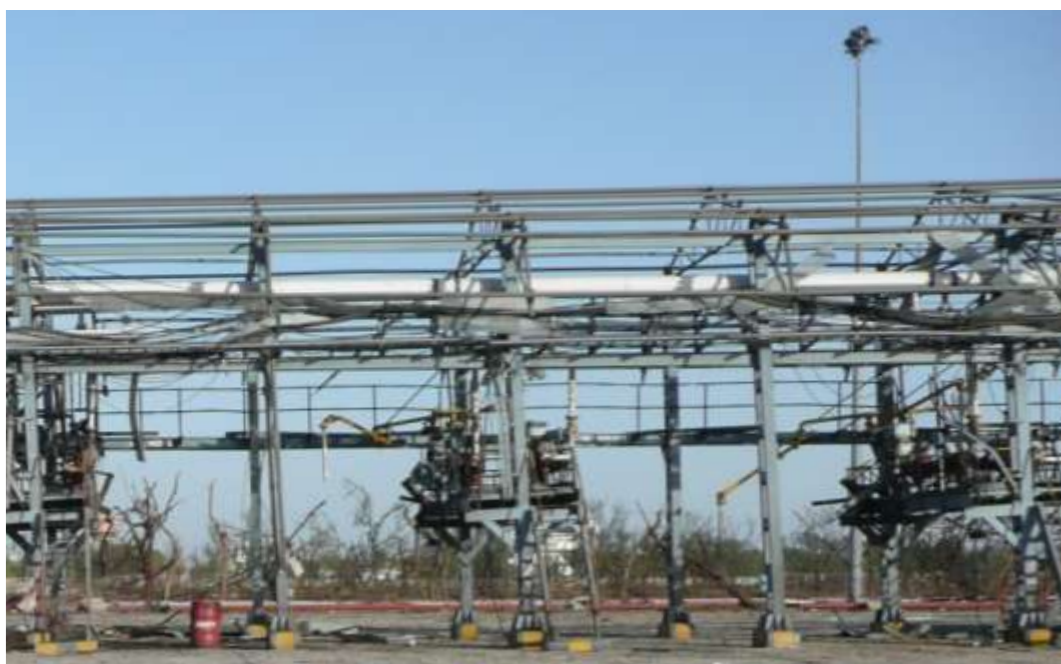
Figure 42: Displacement of the tanker loading gantry (viewed from the west)

The tanker loading gantries showed evidence of bulk overpressure loading. Figure 42 shows that the gantry had been displaced slightly to the north.

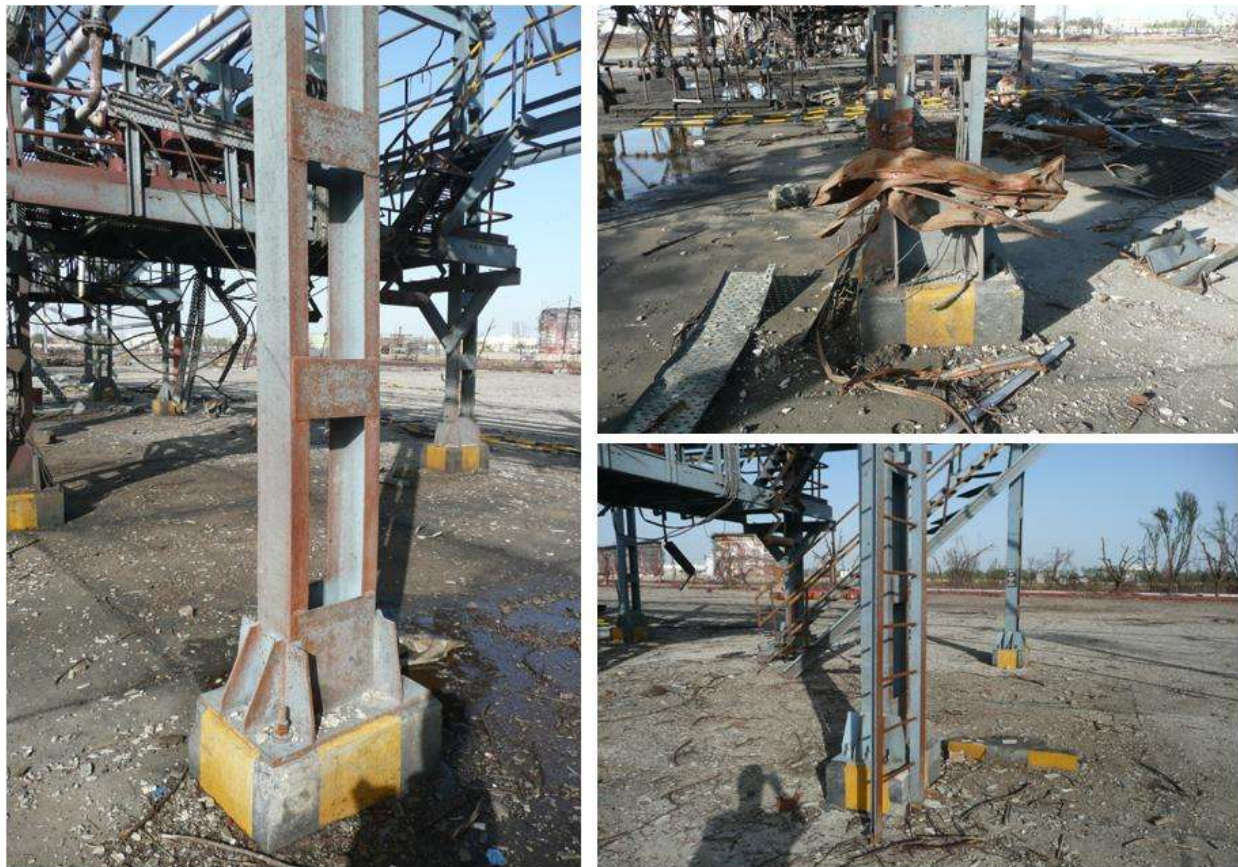
Figure 44: Directional indicators in loading gantry

Directional indicators within the loading gantry were provided by paint scoured off the southern faces of the steel structure, which had then rusted, as shown in Figure 44 (left and bottom right pictures).

The top right picture in Figure 44 shows steel sheet wrapped around one of the gantry supports. In all the instances, the directional indicators suggested flow that was towards east of north.

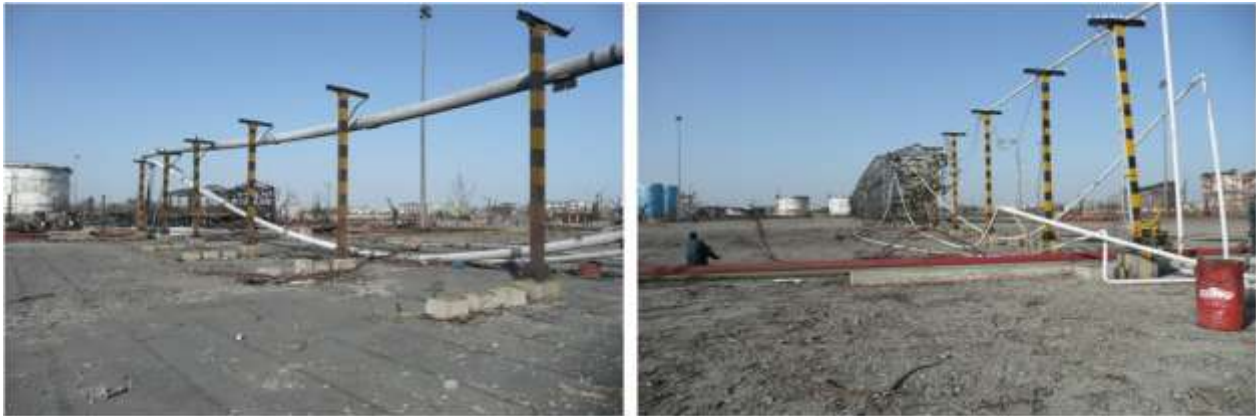
Figure 45: Pipework at north (left) and south (right) ends of the tanker loading gantries

Pipework to and from the north and south ends of the gantries had fallen off its stands, as shown in Figure 45. The pipework at the north end had fallen to the east side of the supports, whilst the pipework at the south end had fallen either side of the supports.

Directional indicators were present on this pipework and the supports in the form of scoured paintwork allowing the steel to rust.

At the north end, the scouring suggested a more north easterly direction, whereas at the south end, the indicators scouring was suggesting a more northerly direction.

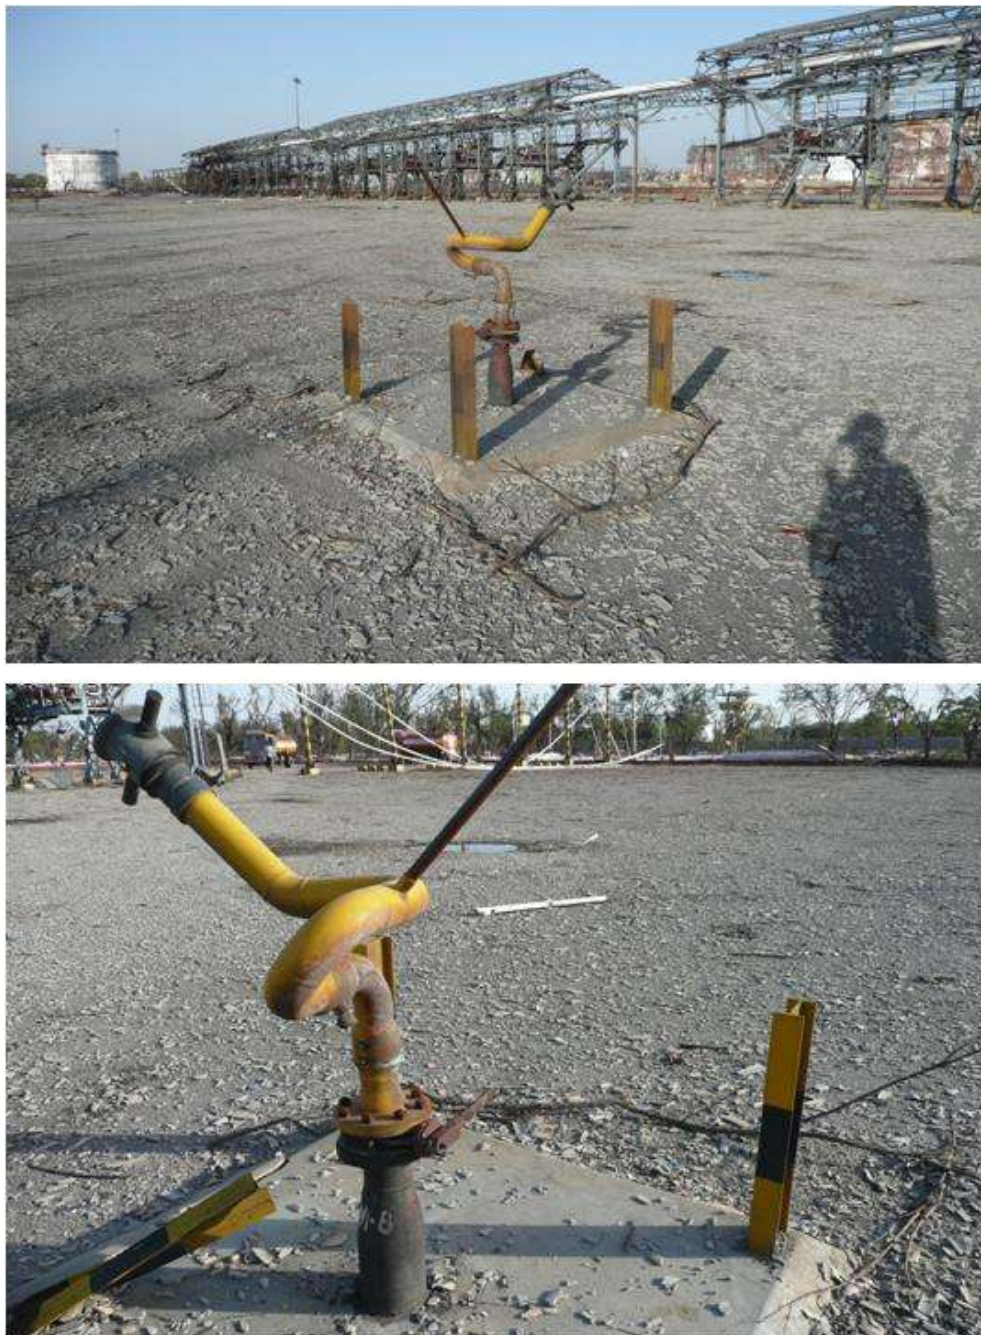
Figure 47: Fire hydrants adjacent to the tanker loading gantries.

In addition to the tanker loading gantries, the area also contained six fire monitors, with three down each side. These fire monitors were positioned about half way between the gantry and the edge of the open tanker loading area. Figure 47 shows two examples of the fire hydrants. Scouring of the paintwork had occurred on all six of the fire hydrants (and can be seen as a red colour on the yellow pipe on the lower picture). Again the scouring indicated a flow direction to the east of north.

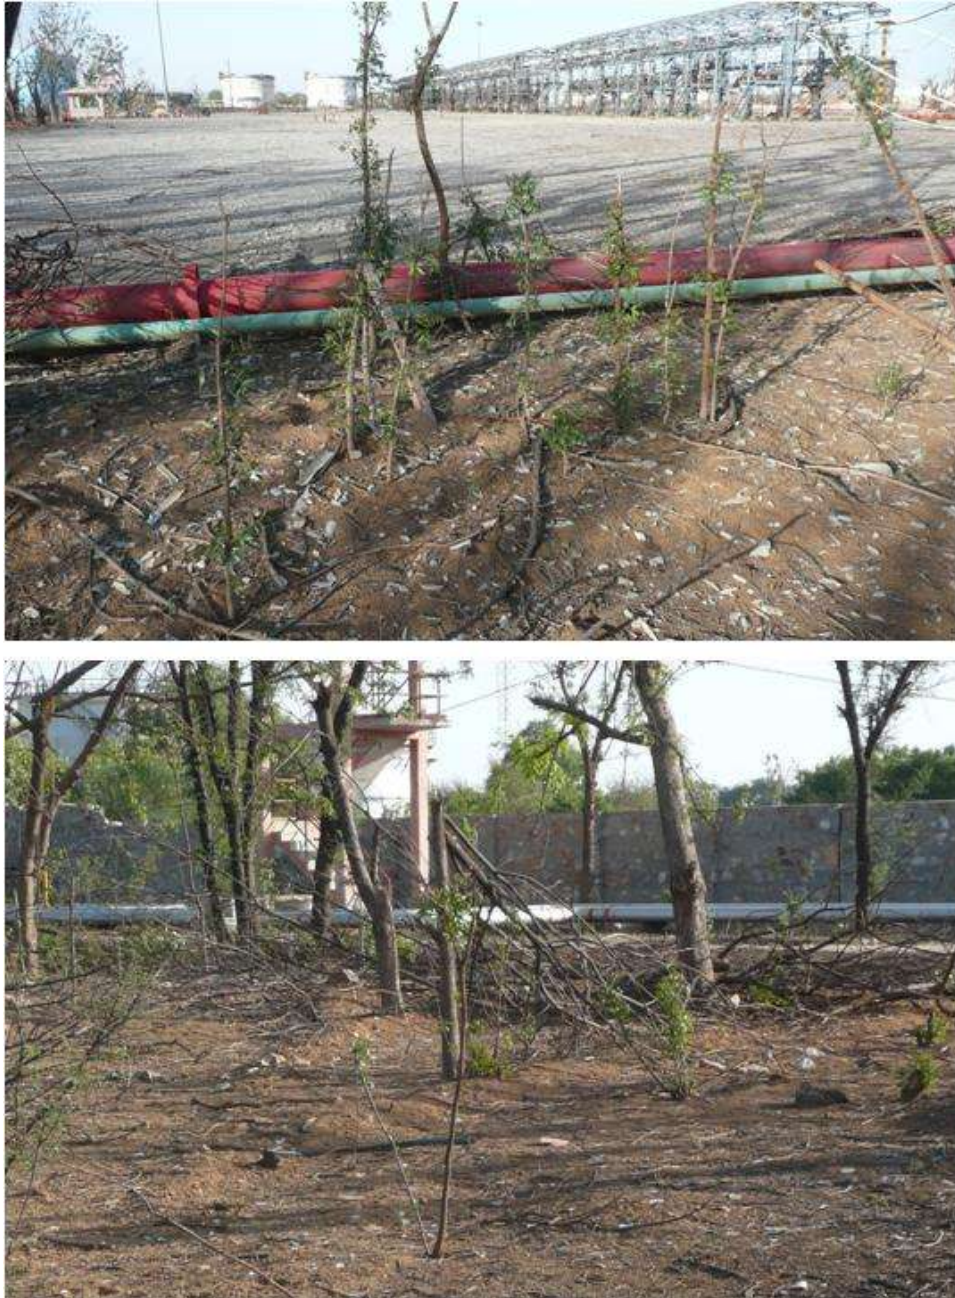
Figure 48: Area of trees to the south of the tanker loading area

Finally for this area of the site, there was a small area of trees to the south of the tanker loading area. Figure 48 shows the beginning of this area, where directional evidence, consisting of leaning bushes and scouring, indicated a northerly flow direction (top picture). However closer to the southern edge of this area,

there was evidence of branches having broken in a southerly direction (lower picture). This suggests that the vapour cloud reached down to the south end of the tanker loading area and extended to some degree into the area of trees. However it does not appear to have extended all the way through this area to the southern site boundary.

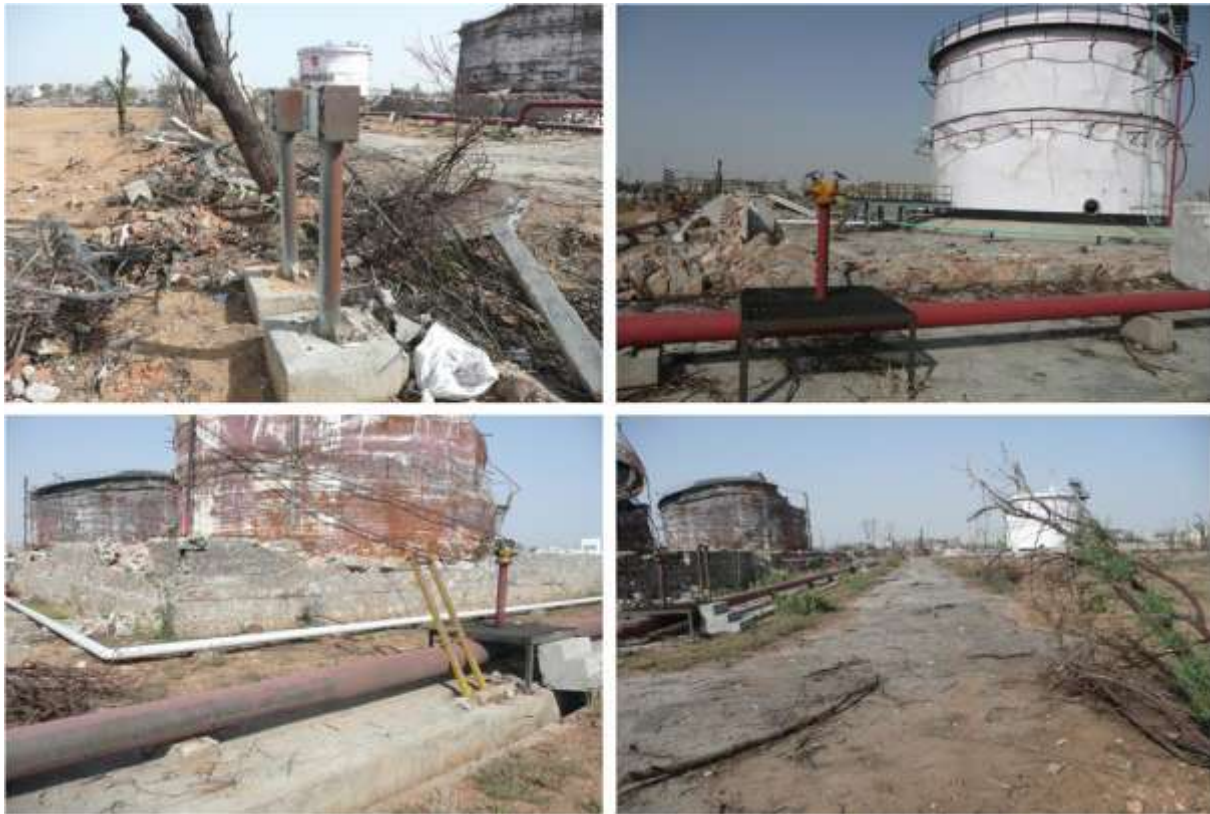
Figure 50: Directional indicators in the area around Tanks 409 A/B/C

There were a significant number of directional indicators around the area of the three tanks. Figure 50 shows some representative examples; scouring was present of paintwork on posts, boxes and fire hydrants (top pictures). The leaning tree in the top left picture also provides a directional indicator.

In all cases the indicators were consistent with a flow in a northerly direction.

The top right picture in Figure 50 also shows that Tank 409C had suffered crushing damage. This tank did not catch fire.

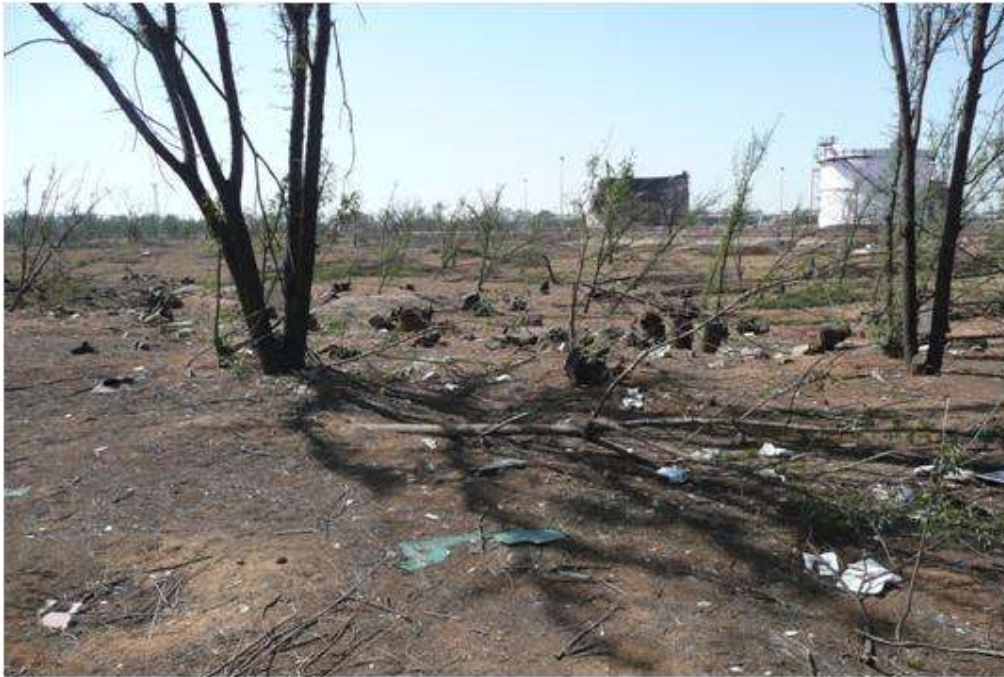
Figure 51: Open area in south east corner viewed from east side (Tanks 409B/C in the background)

Further to the east and south, the ground was relatively open with areas of trees and bushes. Figure 51 shows this area viewed from the east side looking west towards Tanks 409 A/B/C. It can be seen that most of the trees and small bushes are leaning to the right, which is slightly to the west of north.

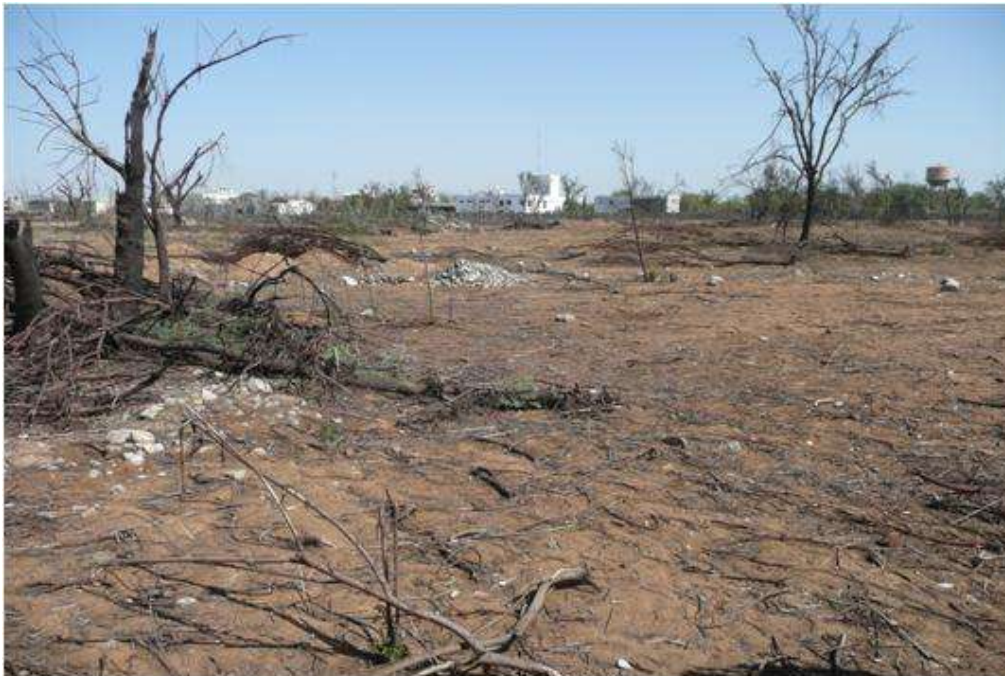
Figure 52: Open area in south east corner viewed from a point close to Tanks 409 A/B/C

Figure 52 is viewed from the other side of this area, near Tanks 409 A/B/C and looking in a south easterly direction. This suggests that the flammable cloud extended across much of the south east corner of the site. However there was insufficient time to explore this area fully and it is therefore not possible to determine how close the flammable cloud got to the south eastern corner of the site.

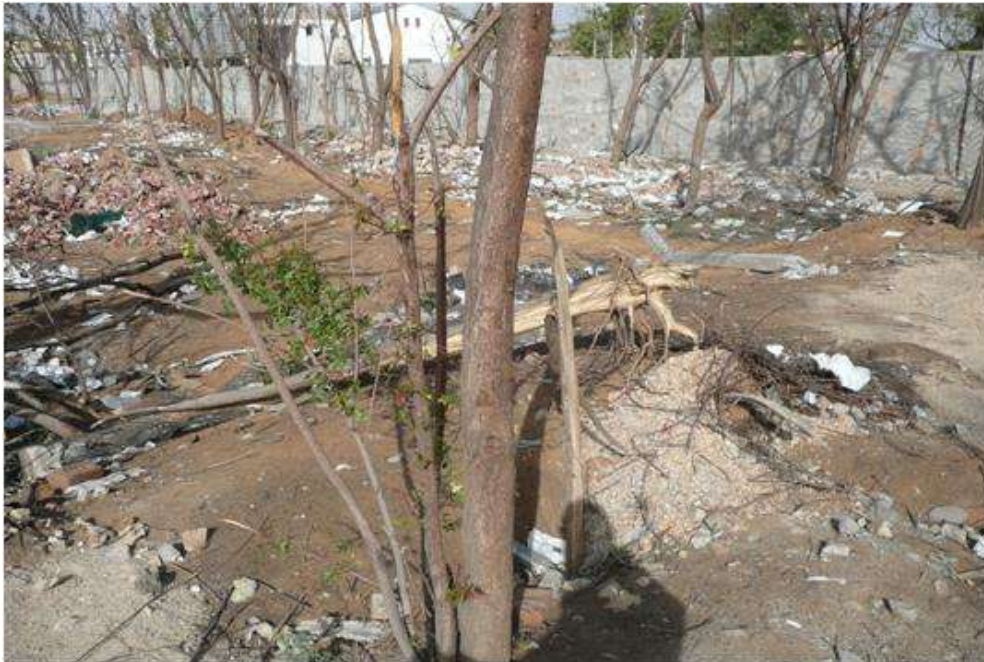
Figure 53: Tree at east end of the road along the southern boundary of the Pipeline Division area (site east wall in the background)

Finally, the northern most part of this area was marked by an east west road that passed along the southern boundary of the Pipeline Division. The trees along this road gave north to north-west directional indication, both in the form of leaning trees and scouring. Figure 53 provides an example, showing scouring on the right hand side of a tree at the east end of this road.

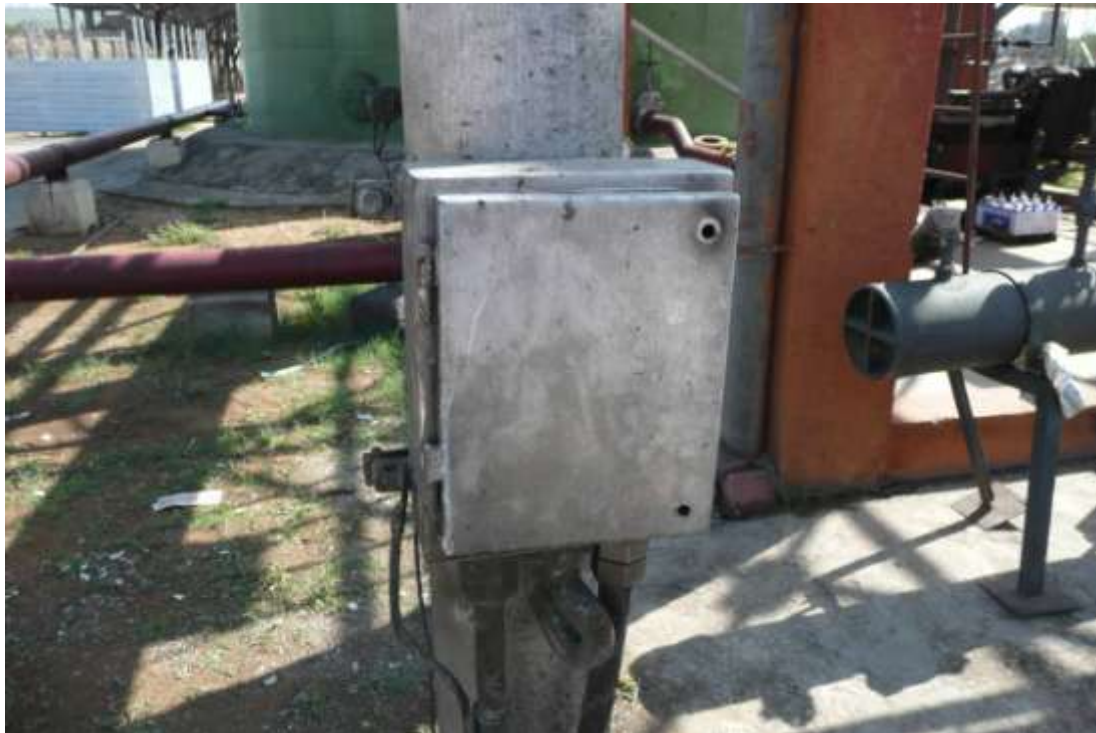
Figure 58: Lamppost and box by pump house

The degree of scouring was variable, being very pronounced on some lampposts, relatively mild on others and in some cases not present at all. The absence of scouring was particularly noticeable along the road to the ponds and also at the pump house just by the green firewater tank. The lamppost by the green firewater tank, shown in Figure 58, seemed to have 'dirty' marks on the side facing south west, but these did not correspond with scouring. There was no pressure damage to the box fitted to this post. It is notable that the scouring shown in the top right picture in Figure 57 is on a lamppost just 40 meters to the south of the lamppost shown in Figure 58.

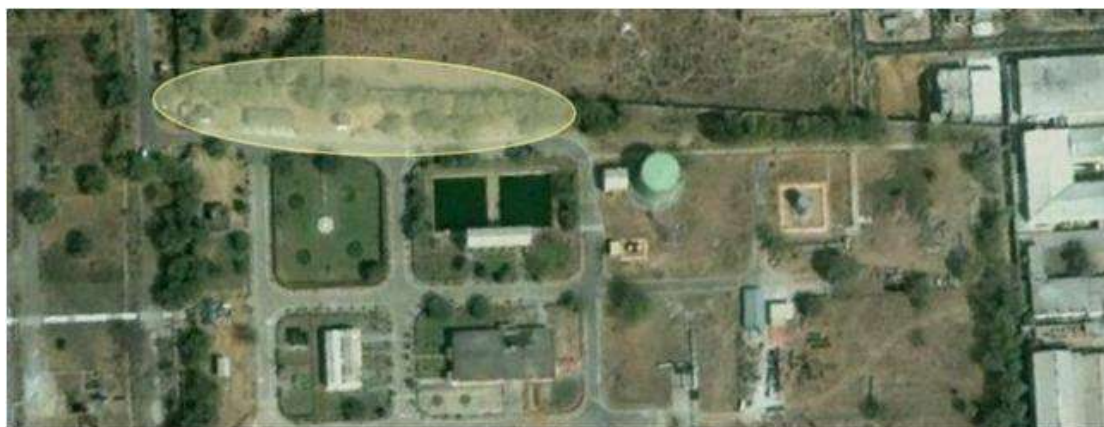
Figure 59: Tree line on west half of north wall

The tree line along the west end of the north wall, as shown in Figure 59, showed some signs of directionality in the form of scouring consistent with an easterly flow, but this seemed to disappear towards the east end of this section of trees.

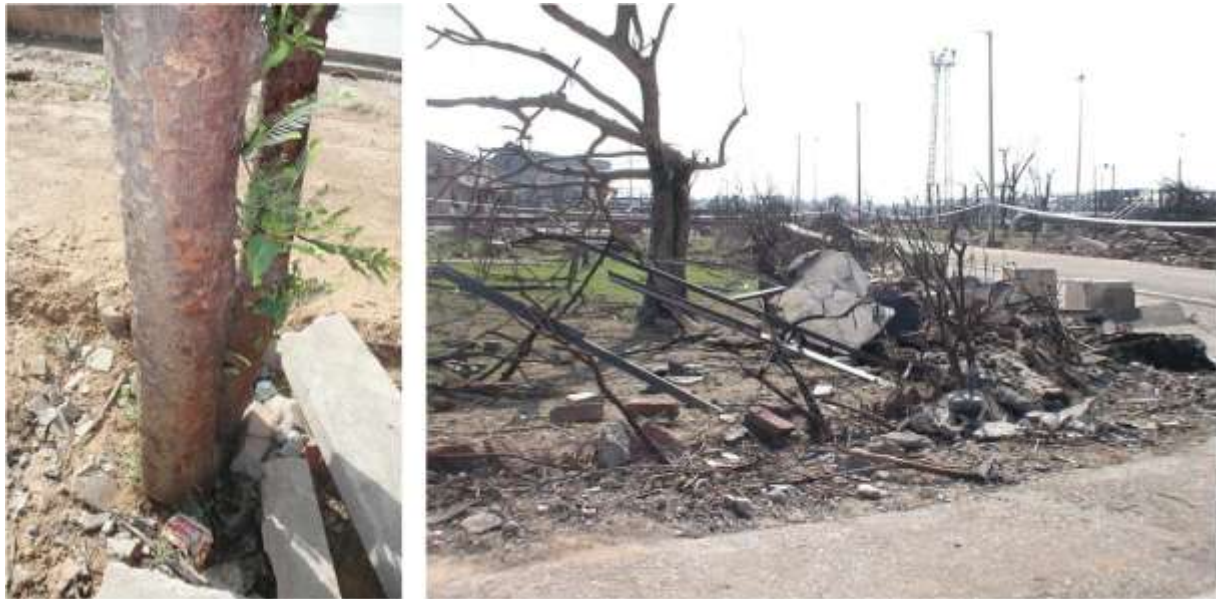
Figure 60: Directional indicators in north west part of the Pipeline Division area (picture on right taken by Dr B. Burgan)

The picture on the left of Figure 60 shows scouring on one of the trees that remained in this area at the time of the February visit. The scouring indicates an easterly direction.

The picture on the right of Figure 60 was taken in November 2009 and is looking south from the north west corner of the park area marked on Figure 55. The tree and steel posts shown in the figure also give a direction indication to the east.

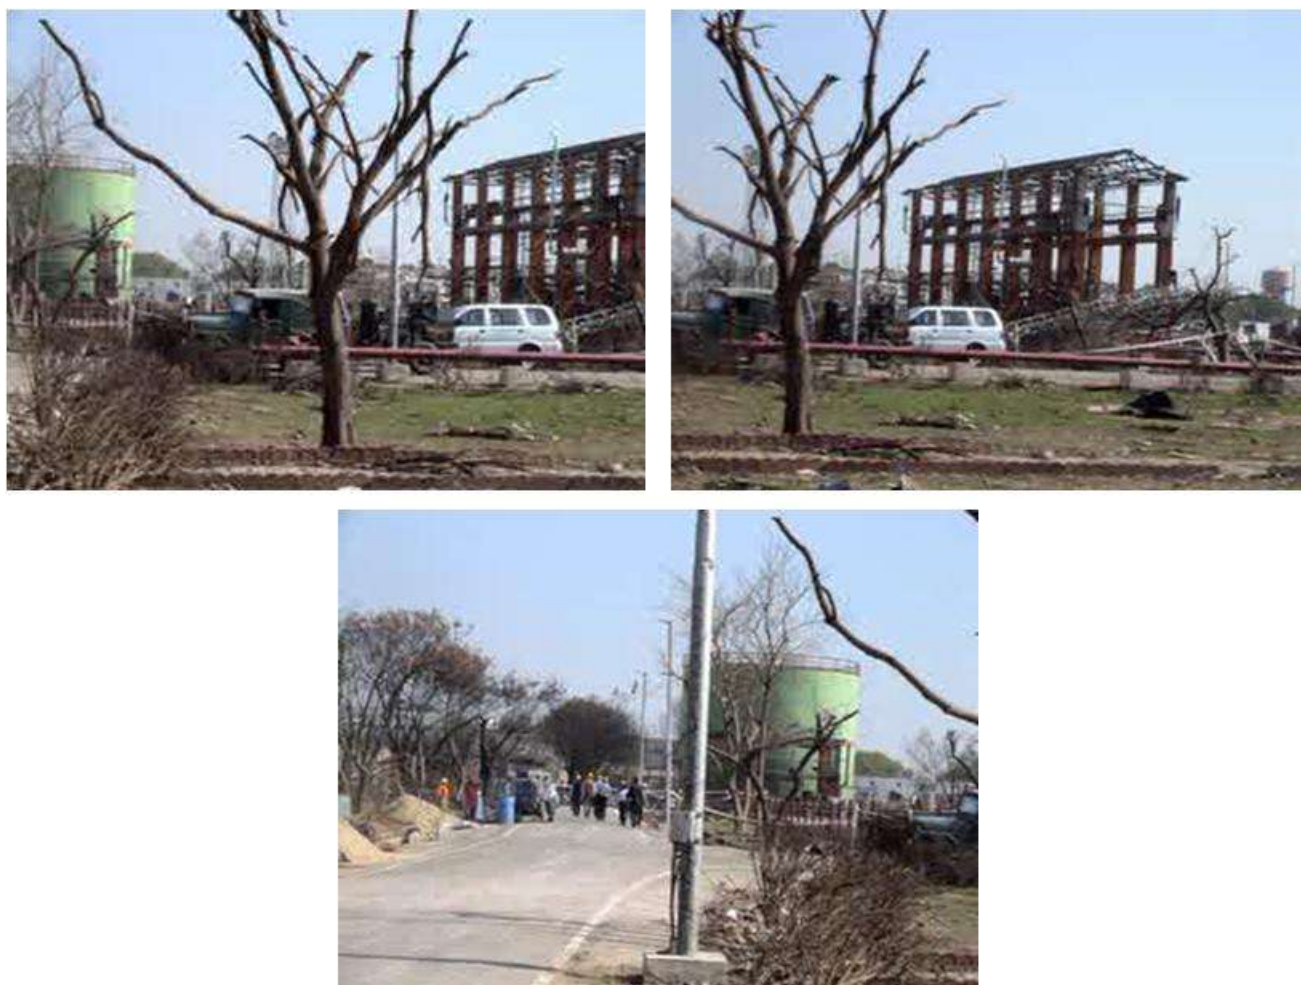
Figure 62: Sequence of frames taken from a video taken from near to the Pipeline Division car park by Dr B. Burgan

Further information from this location is shown in Figure 62. These pictures were taken from a video sequence shot in November 2009. The video was taken from the same position as the right hand picture in Figure 60 and the camera is looking east towards the main firewater pump house and the green firewater tank. The sequence shows what appears to be a camera tower collapsed in a north south alignment alongside the pump house.

This sequence of frames also shows a tree with its branches broken in a southerly direction (top two frames). This tree had been removed by the time of the February visit but consideration of the positions of various items indicates it was on the opposite side of the road to the smoking booth and in the middle of the north side of the park area.

The final frame in the sequence in Figure 62 also shows the relatively undamaged line of trees along the north wall from the firewater tank eastwards. There is also what appears to be an undamaged tree in front of the firewater tank in this frame. This tree was located on the north side of the firewater ponds and appears to be undamaged in its upper branches. It is possible that this is only due to the upper branches being above the cloud and in the absence of any other evidence (the tree had been removed before the February site visit) this is not considered to be a reliable interpretation.

The final point to note regarding the final frame in Figure 62 is that there appears to be scouring on the north side of the lamppost in the centre foreground.

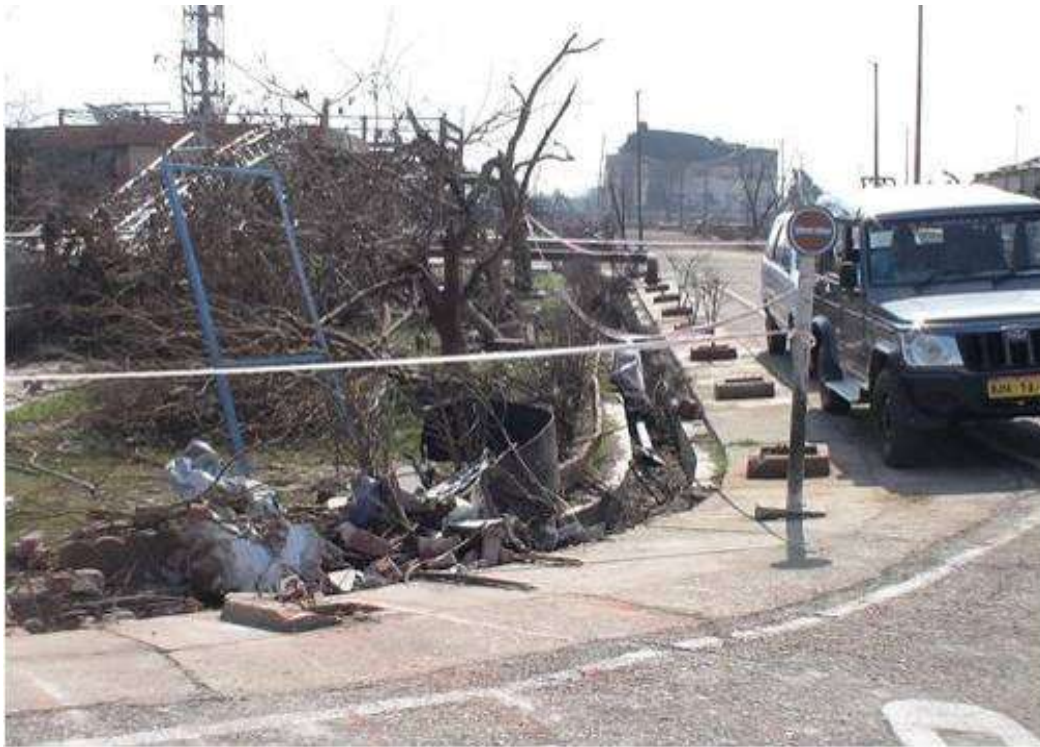
Figure 63: View looking south at north west corner of pond area, Tank 409A in the distance (picture taken by Dr B. Burgan)

Figure 63 shows a view taken in November 2009. This figure also shows directional indicators in the form of trees, a tilted frame and the collapsed tower captured on the video frames shown in Figure 62. Though it is difficult to interpret evidence provided by the trees, overall, they appear to be indicating a flow approximately towards the east, though possibly with a slight northerly component.

The frame is tilted in a south easterly direction, however it should be noted the frame would naturally tilt forwards or backwards as its resistance to sideways deflection is likely to be greater. In addition, on the assumption a sign had been fitted to the frame, the force in the forwards/backwards direction would have been considerably greater than that in the sideways direction. The tilting of the frame therefore only suggests that the force on the face towards the camera was greater than the force on the other side. This would be consistent with flow from (at least) the 90 degree angle from a westerly direction through to the north.

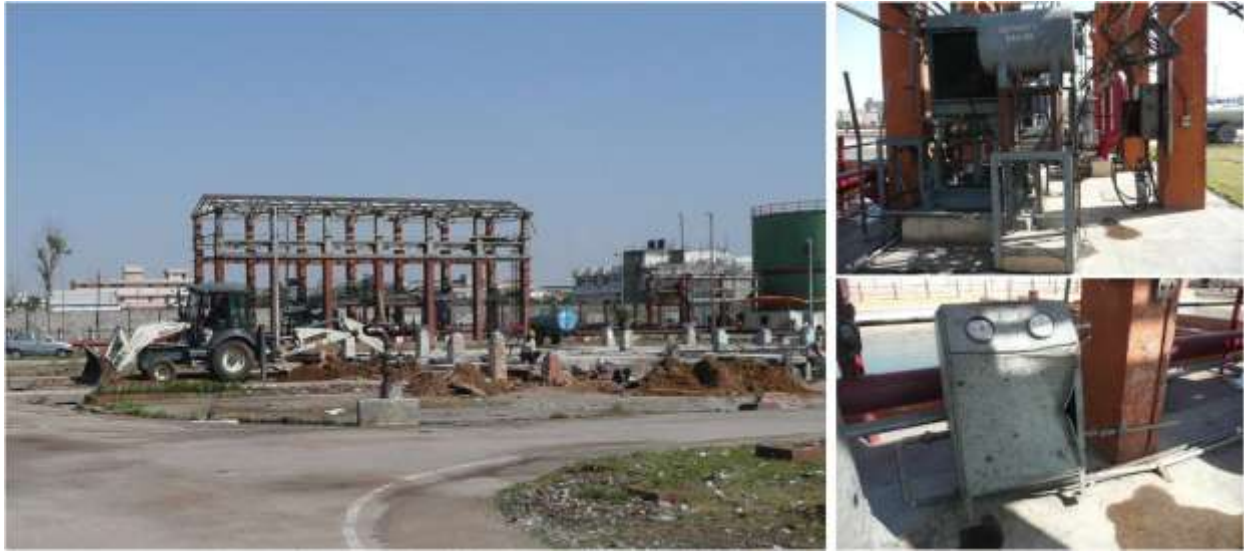
Figure 65: Main firewater pump house in Pipeline Division

Figure 65 shows the main firewater pump house in the Pipeline Division area. This pump house was located to the west of the green firewater tank and just south of the firewater ponds. It is understood that there had been a roof on the structure, but it had been relatively open on the sides. There was little in the way of congestion in this building and the only pressure damage observed to equipment was to an instrument unit where the front panel had been distorted inwards and it was tilted backwards. The sides of the box did not show signs of crushing. This evidence would be consistent with it being struck by a blast wave on its front face.
