Report Number: 11510

August 2011

Characteristics of the Vapour Cloud Explosion Incident at the IOC Terminal in Jaipur, 29th October 2009

GL Noble Denton

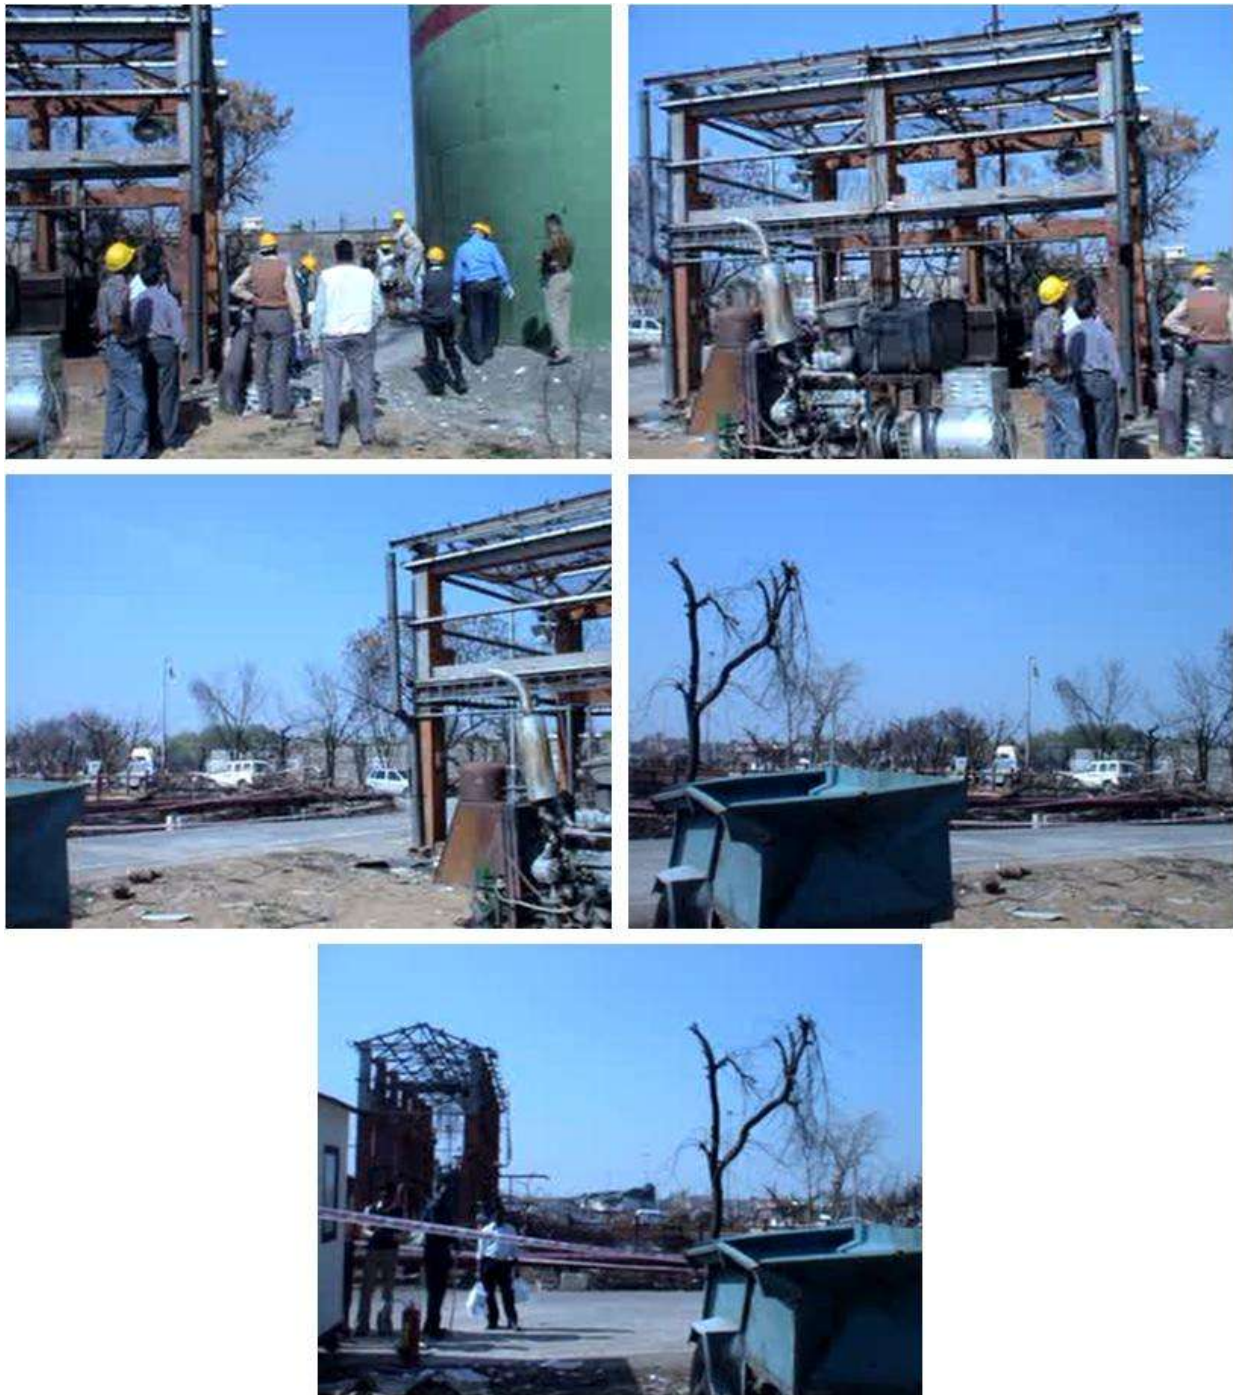
Figure 67: Sequence of frames taken from video shot near firewater tank in Pipeline Division area by Dr B. Burgan

These frames show that the north wall had not collapsed to a position west of the main firewater pump house, which can be seen in the bottom frame. The second frame down on the left also appears to show a tree collapsed or broken to the north close to the point where the wall changes from being undamaged to collapsed. This may well be one of the trees shown in Figure 66. The middle two frames also indicate that the damage to branches on the trees along the north wall and to the west of the firewater ponds was not as severe as damage to other trees on the site.

Finally, the second frame down on the right and the bottom frame show a tree where the branches have broken in a northerly direction.

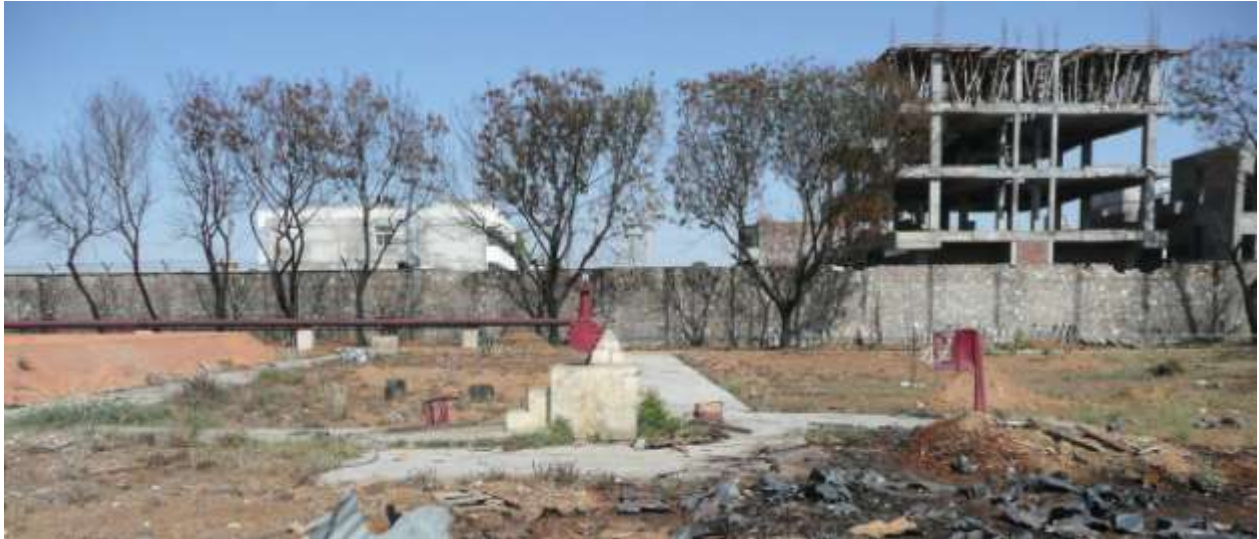
Figure 68: Trees along the north wall at the most eastern end

Moving along this north wall further east and past the green firewater tank, Figure 68 shows that the trees did not appear to show any sign of pressure damage. They did however show signs of having been burned. It is understood from site personnel that this section of wall did not require re-building.

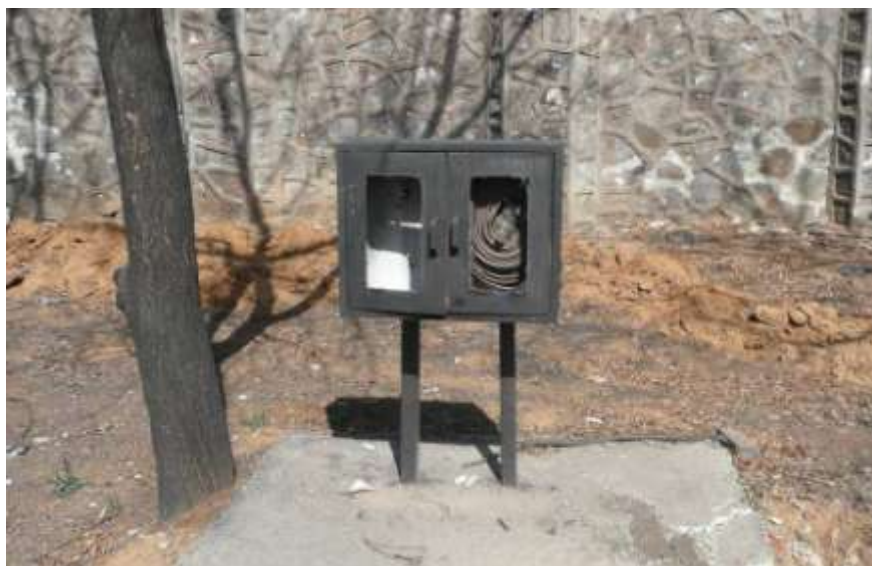
Figure 69: Firewater hose cabinet located to by the north wall to the east of the green firewater tank

The lack of significant overpressure in this area is also supported by the lack of damage to a firewater hose cabinet located close to the north wall in this area, as shown in Figure 69. Though clearly fire damaged, this cabinet does not show any obvious pressure damage.

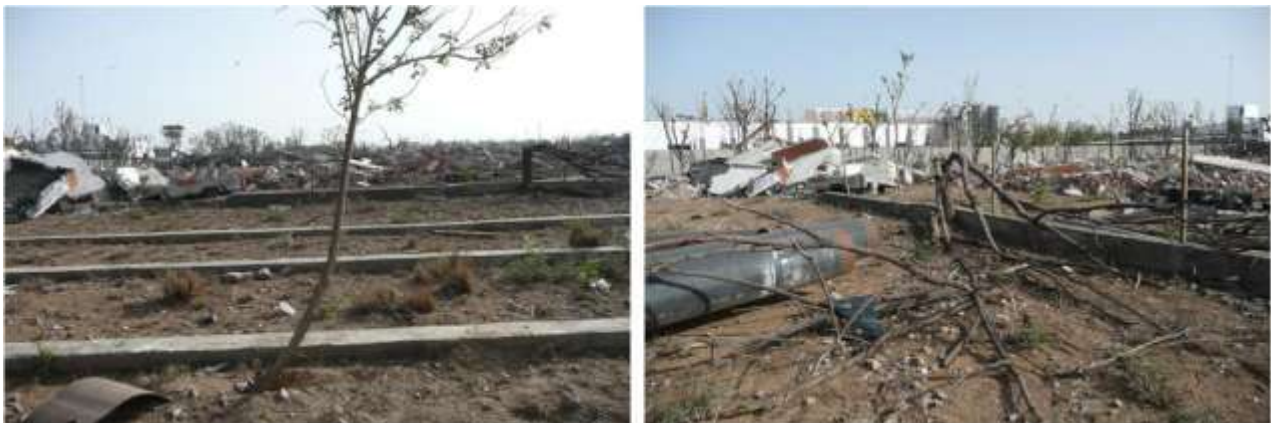
Figure 72: Trees at the east end of the Pipeline Division area

Much of the ground at the east end of the Pipeline Division area had been covered with debris removed cleared from the damaged buildings. However, two trees were still present, being some 40m west of the east wall and 80-90m south of the north wall. These trees are shown in Figure 72. Both provide a direction indication consistent with flow in to the west. The tree in the left hand picture (taken looking south) also showed clear scouring on the east side of the trunk. Note that the tree shown in the right hand picture can be seen in the background of the left hand picture.

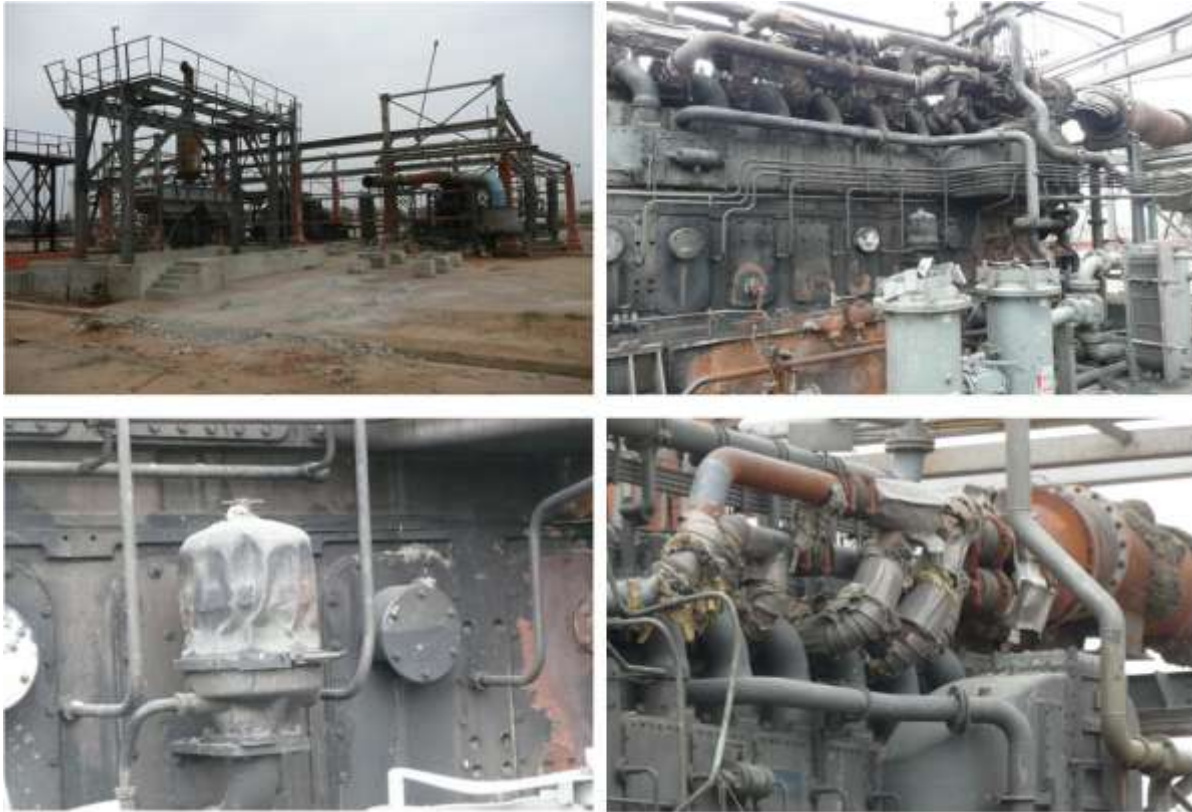
Figure 75: Pipeline pump building in February 2010

Figure 75 shows the pipeline pump house and the diesel engines as they were in February 2010. There was evidence of pressure damage to the oil filters on both engines. This damage was consistent with the damage observed at Buncefield, however, it should be noted that the oil filters on the IOC site were larger. It is notable from the two right hand pictures in this figure that there appeared to be only limited damage to the exhaust system from the tops of the engines. This does not appear to be consistent with the oil filter damage.

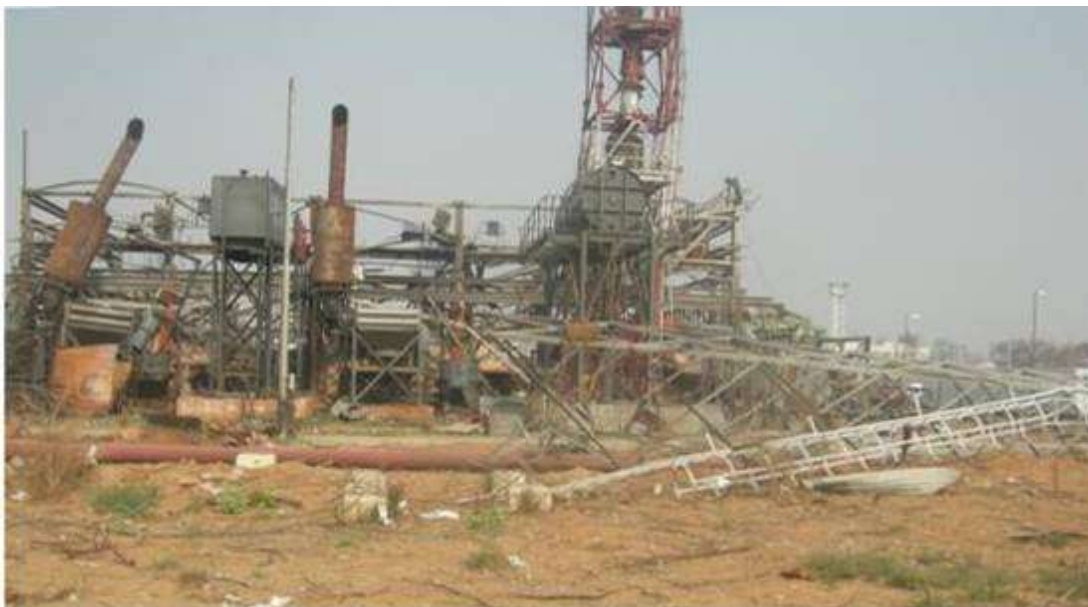
Figure 76: View of pipeline pump house from the south (picture taken by Sh. S.K. Hazra on 11th December 2009)

As has been noted, the pipeline pump house had been tidied up by February 2010. Figure 76 shows the pipeline pump house, viewed from the south, before the clear up operation. The picture shows that a tower to the south of the building had collapsed, possibly in an easterly or north easterly direction. In addition, one of the exhaust stacks from the diesel engines appears vertical whilst the second one, on the left, has tilted to the east.

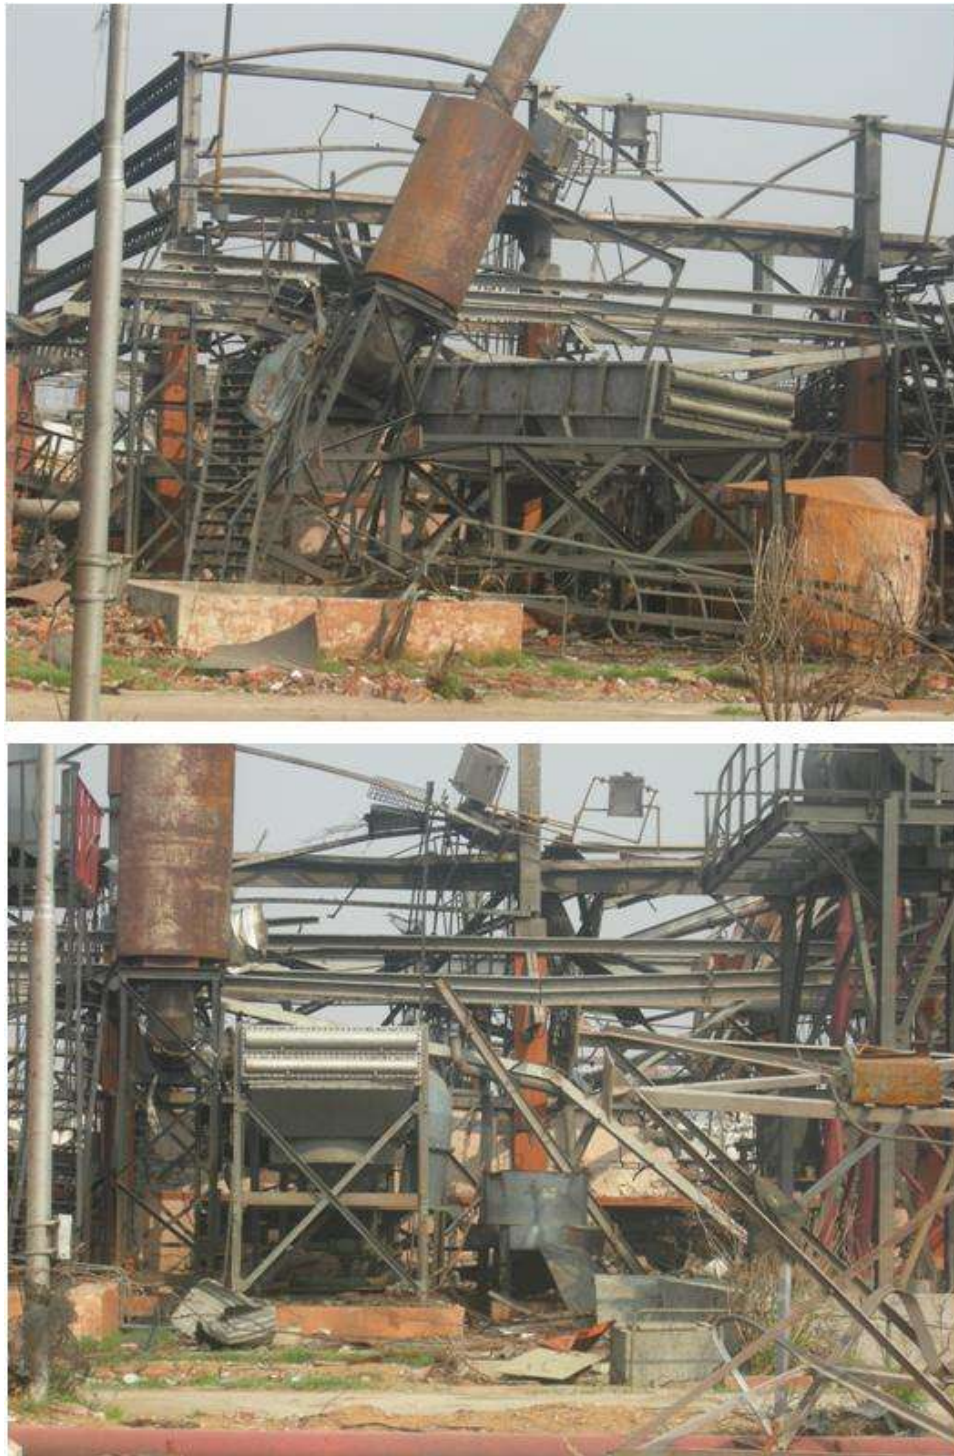
Figure 77: Closer in views of the two exhaust stacks on the pipeline pump house (pictures taken by Sh. S.K. Hazra on 11th December 2009)

Closer in views of the two exhaust stacks are shown in Figure 77. It should be noted that the building had had a roof and partial walls.

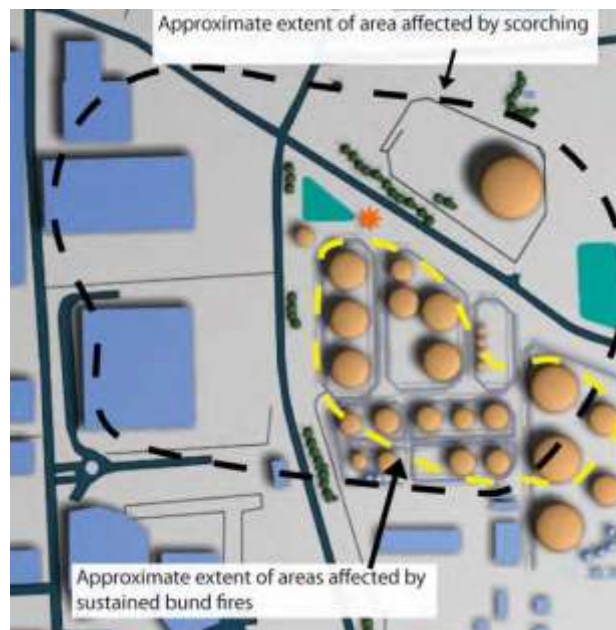
Figure 79: Extent of the vapour cloud was taken to correspond to the scorched area

This appendix provides a description of the types of evidence observed following the Buncefield incident. Most of the information provided in this section has been obtained from the report of the Joint Industry Project [4] and is reproduced here to allow the evidence from Jaipur to be placed in context. In the Buncefield incident, a low lying vapour cloud was produced following the spillage of about 300 Tonnes of MS. The vapour cloud spread across the site and offsite with the scorched area indicated in Figure 79 taken to define the extent of the flammable cloud.

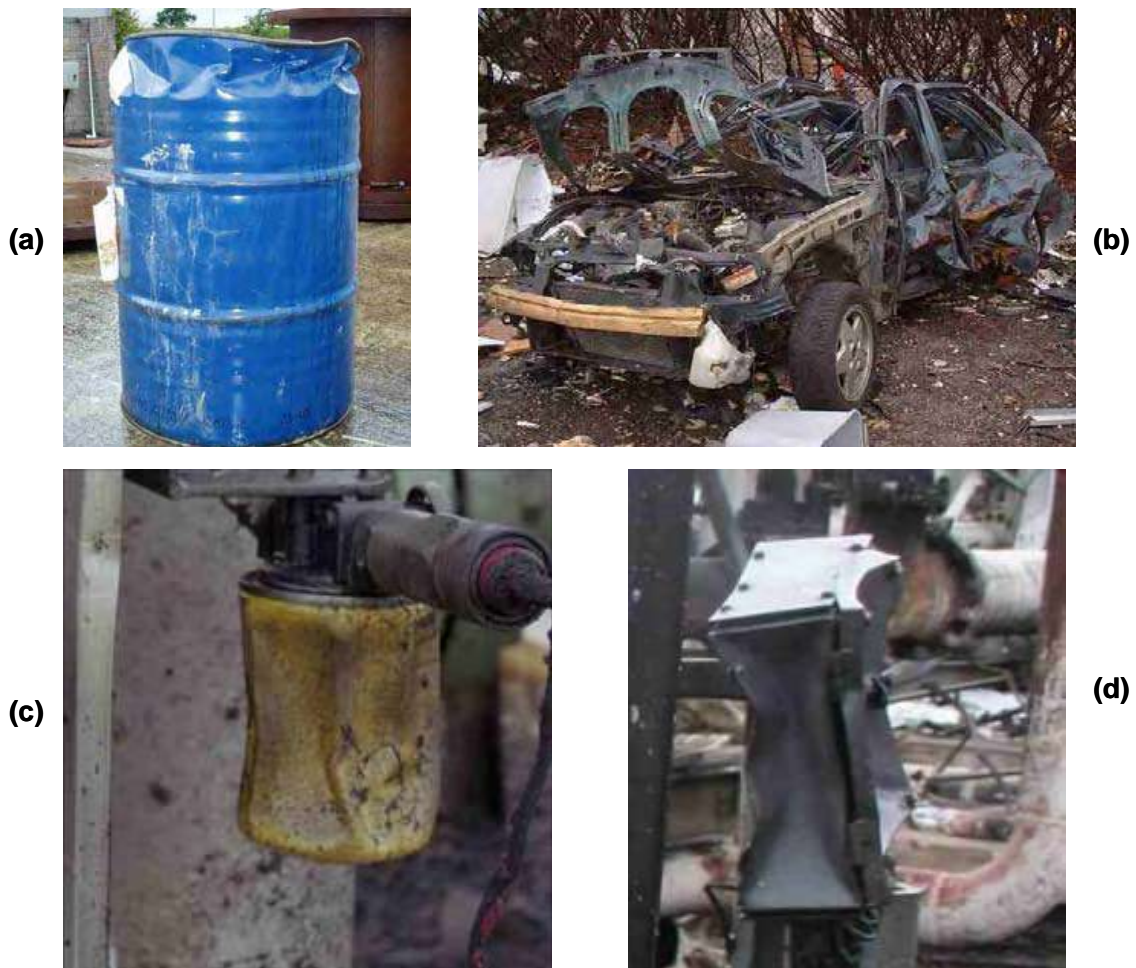
Figure 80: Examples of the types of pressure damage observed within the Buncefield cloud; (a) Damage to near full steel drum in static test; (b) Damage to car; (c) Crushing of oil filter; (d) Crushing of steel box

Examples of the types of damage observed within the Buncefield vapour cloud are shown in Figure 80.

A number of steel junction boxes were found within the area engulfed by the cloud. Typically these boxes had been crushed in on the sides

The Buncefield Joint Industry Project conducted a number of experiments including static loading tests and dynamic tests involving exposure to pressure waves generated by high explosive. The results of these experiments indicated that overpressures in excess of 200kPa were required to cause the observed pressure damage.

Damage to cars and vans within the cloud was extensive. On the basis of experimental studies and comparison with data from earlier studies, the project concluded that the cars had seen in excess of 200kPa overpressure.

A crushed oil filter was observed within the area of the cloud. The project concluded on the basis of experimental work that the filter had been exposed to overpressures well in excess of 180kPa.

The drums had often been exposed to a combination of compression from the explosion followed by heating by the subsequent fires. However, static experiments indicated that the deformation of near full drums was typically of the form shown in Figure 80. The drum is compressed and deformed above the liquid level in a manner consistent with observations on site.

The experiments indicated that overpressures in excess of 180kPa would be required to cause the observed damage.

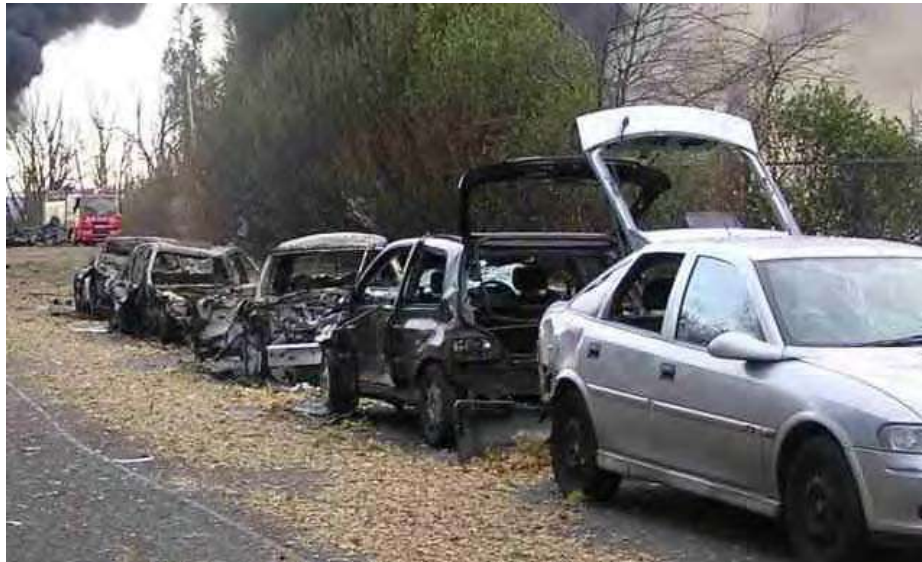
Figure 81: Change in Damage Level to Cars at the Cloud Boundary

As already described, severe overpressure damage was observed within the vapour cloud. It was also observed that the degree of damage fell rapidly from the edge of the cloud. This is illustrated in Figure 81, which shows a sudden change in the level of overpressure damage to a row of cars that appears to have traversed the cloud boundary. The cars at the far end of the row show severe pressure damage, however the car in the foreground shows significant damage at the rear of the car.

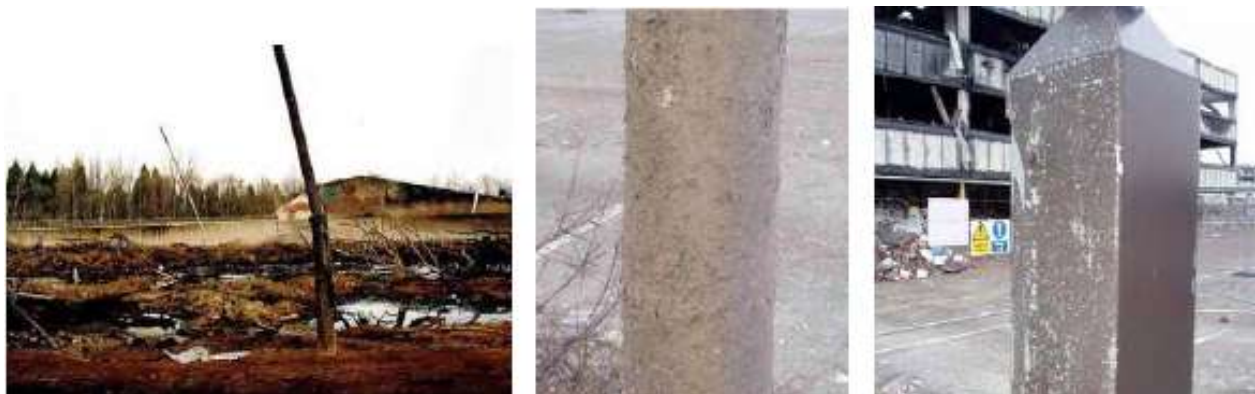
Figure 82: Directional indicators inside the Buncefield cloud

Many directional indicators were observed following the Buncefield incident. These consisted of bent posts, scoured paintwork and trees and translation of some objects. Examples of directional indicators are shown in Figure 82

Simulations carried out for the Joint Industry Project showed that both fast deflagrations and detonations passing through a low lying vapour cloud give a net dynamic load that is in the opposite direction to the propagation of the deflagration or detonation. This is primarily due to the high velocities generated in the combustion products venting behind the flame or detonation. The high velocity gas would also give the scouring of trees and paintwork and translate some objects.

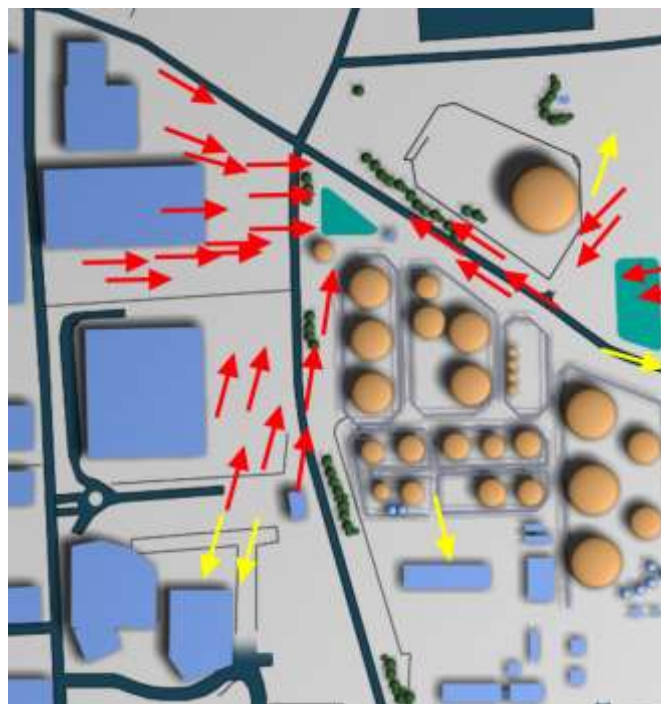
Figure 83: Buncefield directional indicators

Taking the directional evidence inside the cloud as indicating the direction of flow of the combustion products, the evidence was plotted on a map of the site, as illustrated in Figure 83 (red arrows).

As can be seen, the directional indicators were present throughout most of the vapour cloud. This evidence was probably the most important in distinguishing between the 'deflagration only' and the 'deflagration to detonation transition' scenarios considered by the project. The deflagration would have only given these directional indicators within the congested regions (the tree lines). Outside the congested regions, items would have been bent away from the explosion source (as they are only affected by the blast wave and not the high velocity combustion products). This was not what was observed, with items only being bent away from the explosion source outside the cloud, as illustrated by the yellow arrows on Figure 83.

Given that the arrows within the cloud point in the opposite direction to the direction of propagation of the detonation, their tendency to point towards a single location was taken to indicate the area where the transition from deflagration to detonation occurred.
